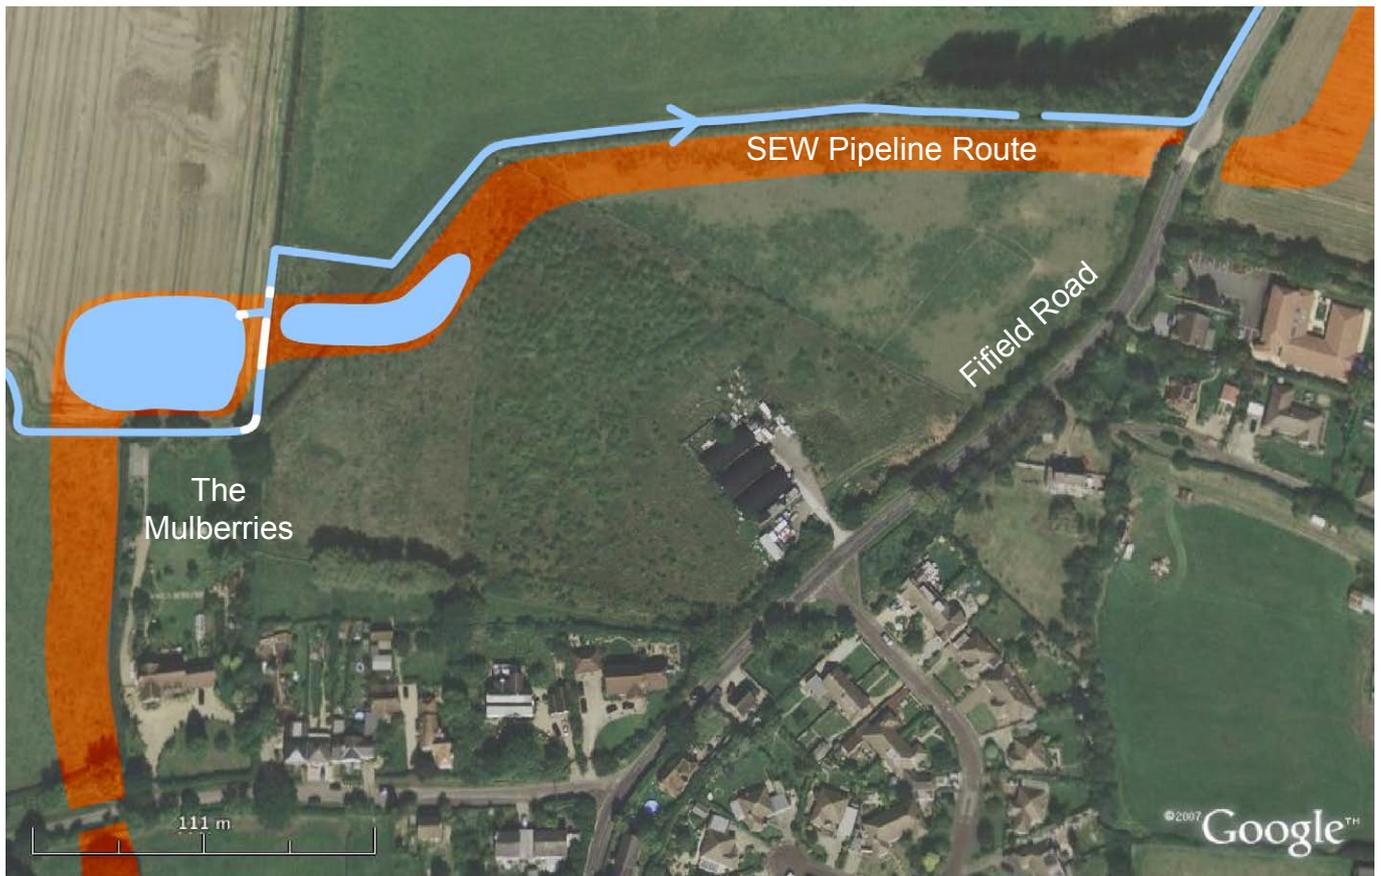
As a result of SEW pipeline work a lot of water accumulated here during the winter unable to escape via its normal route due to filled ditches and blocked pipes. A large lake formed and together with the blocked ditch running behind the Mulberries was beginning to seriously affect the rear of that property with the garden and paddock becoming completely saturated.

Councillor Grenville Annetts in his role as liaison with SEW managed to get them to cut a channel for water to escape from the lake and partly re-open the ditch where the temporary pipe had become blocked. The level of water in the lake dropped by a few inches but because of the limitations of the location the mechanically cut channel had a high point at the furthest reach of the bucket preventing any further flow.

The full ditch running behind the Mulberries was also still not functioning as the SEW clearance was still above water level. It was also blocked on a right angle turn at the rear corner of the Mulberries.

OGAFCAP volunteers cleared the ditch blockage at the corner and the length of ditch leading to the Pipeline blockage. The clearance at this stretch was then improved but still not sufficient to allow the now flowing water from the Mulberries ditch to progress further. This was due to the temporary pipe still being embedded in the clay, preventing deeper excavation. Both ends of the pipe were cleared and miraculously the partly buried pipe again began to function, now allowing a healthy flow away.

The high point in the channel from the lake was then cleared away by a further 6 inches or so, allowing a veritable torrent to join the flow in the ditch.

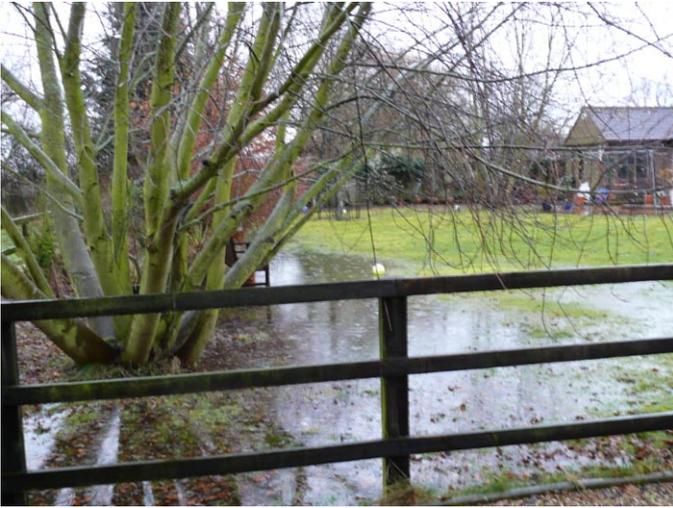
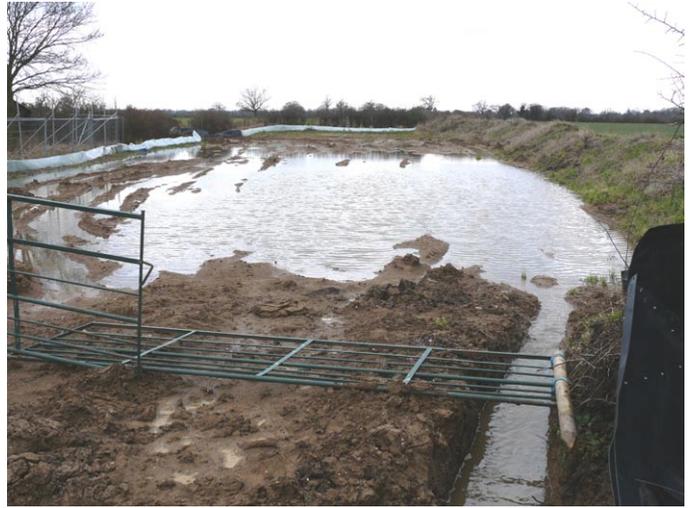
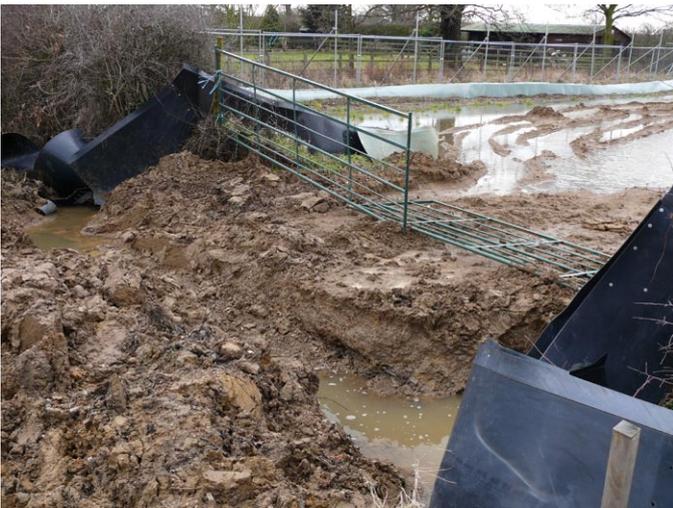
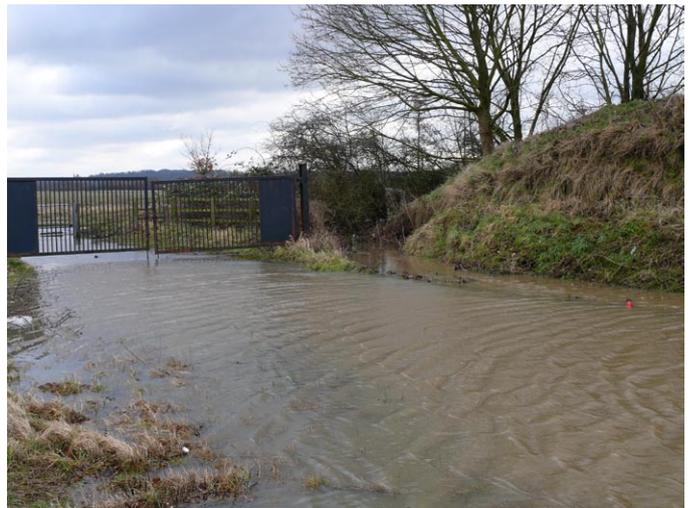
The Newt fencing across the ditch now became a problem as the mesh was collecting silt and debris and forming a dam holding back the flow. This was lifted out of the clay bed of the ditch allowing the flow to pass underneath.

The remainder of the ditch route to join the roadside ditch on Fifield Road was then inspected and found to be blocked at the far end before it reaches the road. This blockage is in an area difficult to access being in a gully between the Biffa bank with trees and the field with the pipeline route, with a hedge at the road end and fenced off at the other.

Although some water is seeping away past this blockage it is in effect making the whole system into a huge sump. While this is serving a useful purpose for the moment it clearly needs to be remedied before next winter. It is just possible that a large digger with a very long reach might be able to tackle this from the pipeline route and we will try to add this request to several others for when completion works begin on the pipeline. Failing this it looks feasible for a volunteer to climb under the fencing across the ditch to tackle this manually. If necessary this will be done if SEW cannot oblige.

There are obviously other things going on at the Fifield Road end as shown in the photo of the Biffa site entrance (bottom right). At the moment it is not clear why this is happening or where the water is coming from to cause it. Clearly the Fifield Road ditch is not coping with it and this issue will need to be analysed "next time round".
