## **9 Wet Spots 2015** **Where are we after 6 years ?**

### **Drainage report 05**

19.09.2015

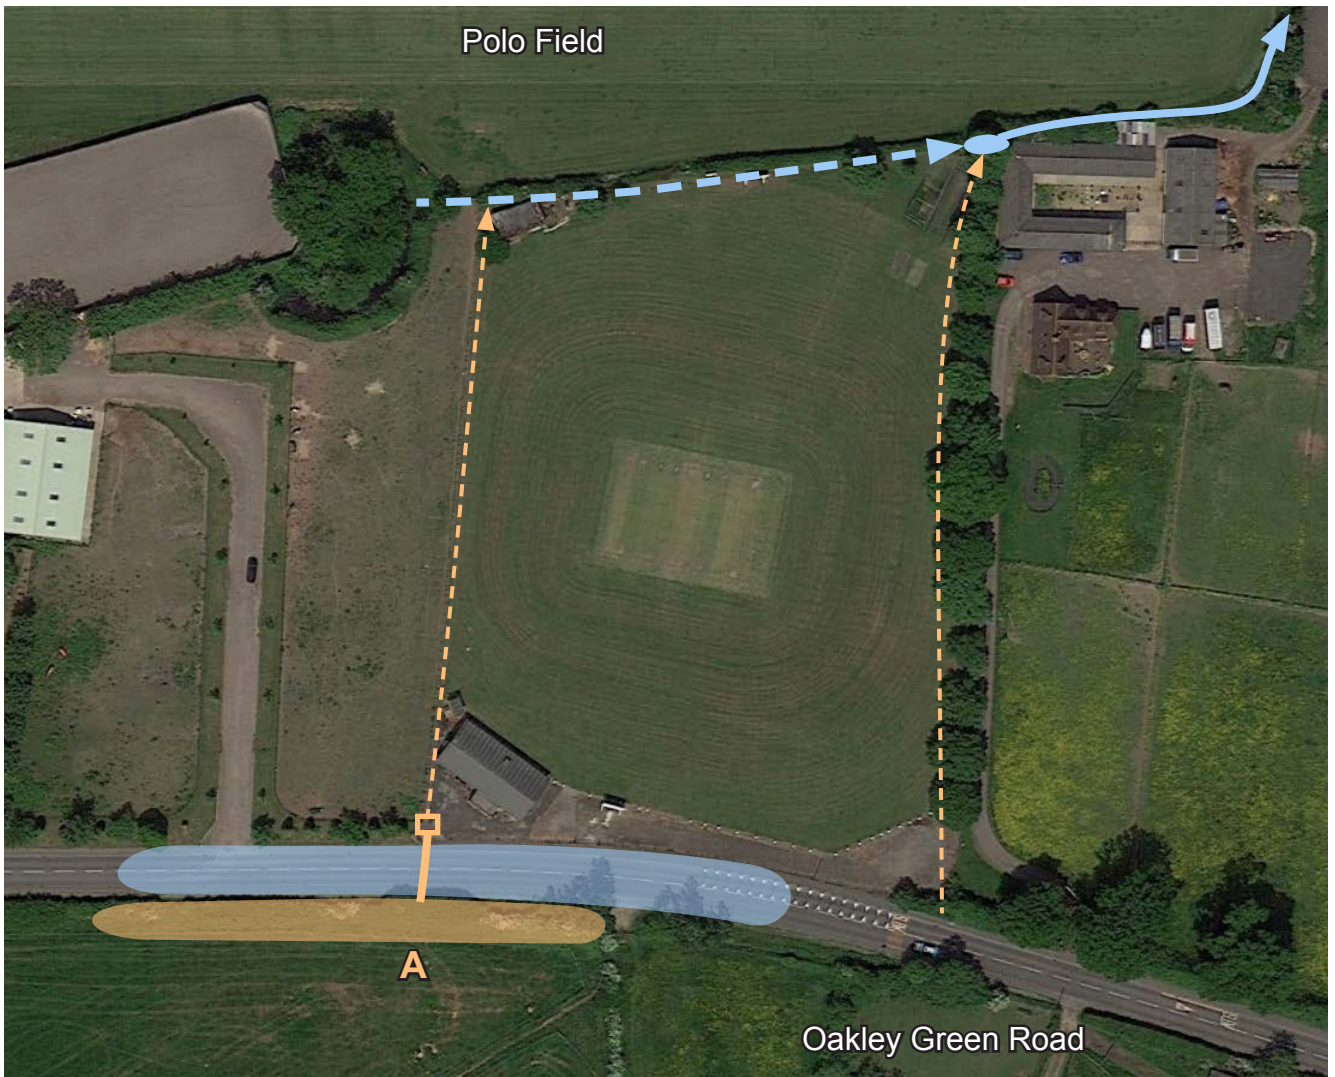
## 1 Cricket Ground - Oakley Green Road

Some early improvement was achieved here when in 2009 an old bucket was cleared from the manhole chamber on the south side of the Oakley Green Road. We thought this was an early success and for a while it seemed to be. But recently the flooding seems to be becoming more frequent again.

Streetcare have confirmed that the culverts crossing Oakley Green Road in the vicinity of the cricket club have again been checked and cleaned. A site meeting took place on Tuesday July 15 2014. The pitch and nets get flooded in the winter and the Oakley Green Road frequently floods along their stretch.

We believe the root cause of the road flooding is an inadequate capacity in culvert and chamber at their south west corner and the underground pipe heading north from there along their western boundary. Until such time as the capacity of this route is increased we do not expect to see any improvement.

We asked Streetcare to investigate further as the Cricket Club were reporting increasing problems also. We need to investigate with landowners the possibility of introducing a sump or pond area to try and hold back excess water at times of heavy rainfall. Consequently we have returned this wet spot to Amber status.

We understand Streetcare has now been considering our earlier suggestions of delaying the arrival of water flowing off the drift road ridge towards this point and increasing the holding capacity of the ditch and ground on the southern side of the road at (A). We await their proposals with interest.

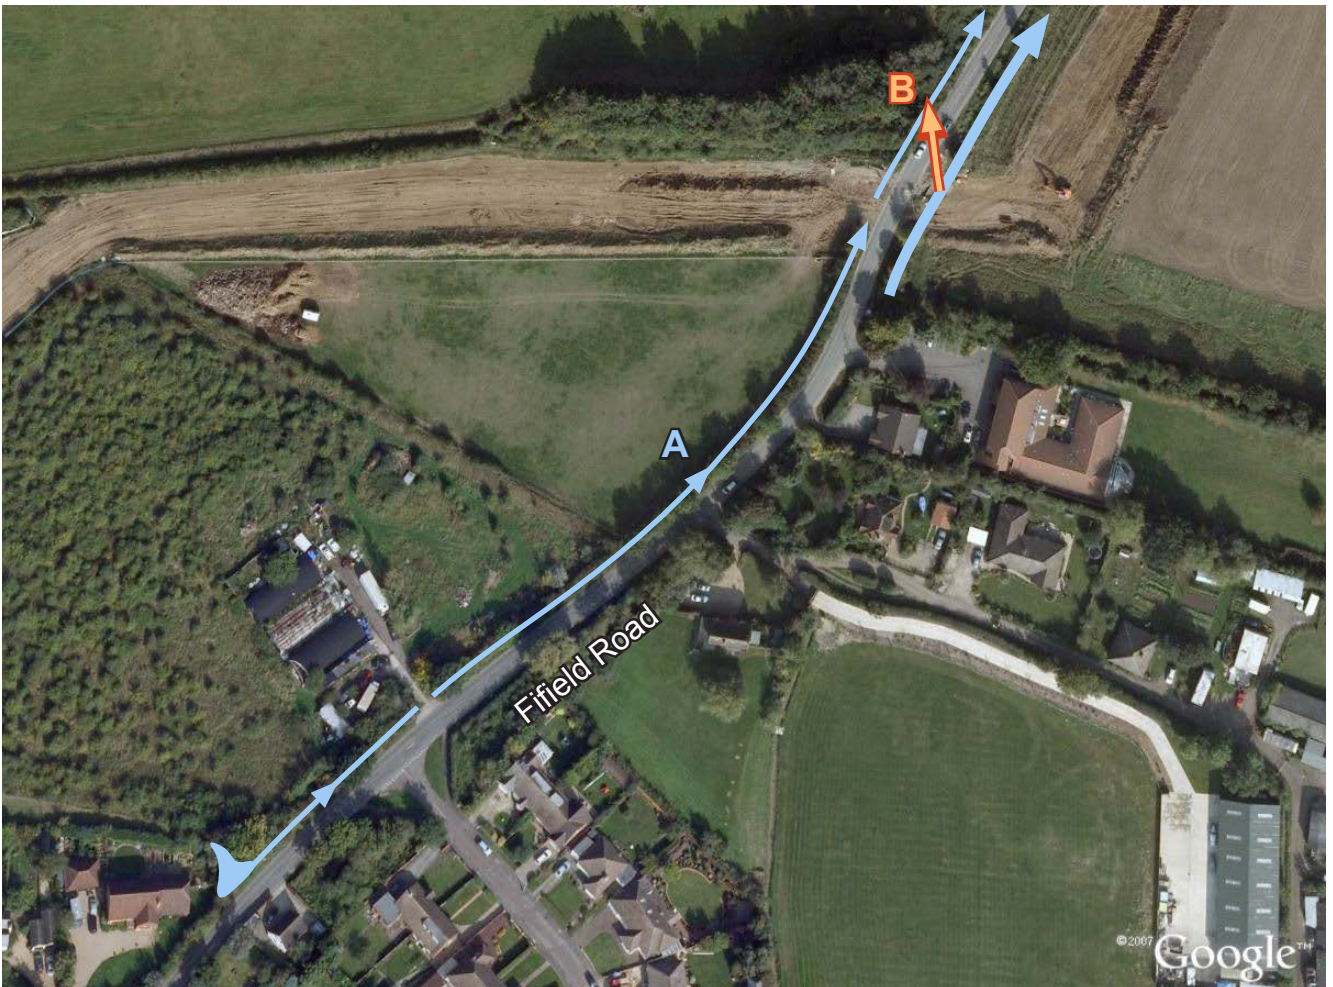
## 2 Speed hump and Fifield Road (north)

A protracted saga of official delays, obstruction by utilities companies, and the deployment of OGAFCA volunteers on 2 occasions. In February 2014 Streetcare contractors finally cleared the ditch at **(A)** on the west side of Fifield Road.

While work was in progress it was noticeable that a culvert just north of Longlea at **(B)** was delivering water from the large eastern ditch into the smaller western stretch. Streetcare said it had been assumed to flow in the opposite direction. The subsequent large volume of water in the smaller capacity western ditch caused a problem further north when entering a pipe just north of Wayside Stables. We requested that the culvert be disabled as the large ditch seems well able to handle whatever flow arrives at that point. Streetcare confirmed that the stoppers they ordered have been installed as a trial.

Wet spot 2 was expanded to include newly reported problems further north on Fifield Road highlighted by re-establishing the flow at the speed bump. On May 7 2014 a site meeting on Fifield Road at the northern boundary of Wayside Stables included Cllr Burbage, Cllr Coppinger, Simon Lavin of Streetcare, the Residents of the nearby property that had been threatened in the recent heavy rain, Grenville Annetts of OGAFCA and the Environment Work Group drainage volunteer. Subsequently Streetcare investigated pipework running north from that point and discovered an area of suspected damaged pipework on the west side of Fifield Road north of Deeds House. They requested plans for underground utilities so that an order could be raised for the necessary excavation and repair. This work was carried out and the two culverts crossing the road in the vicinity of Deeds House were jetted and found to be clear.

We have therefore tentatively returned this wet spot to green status.

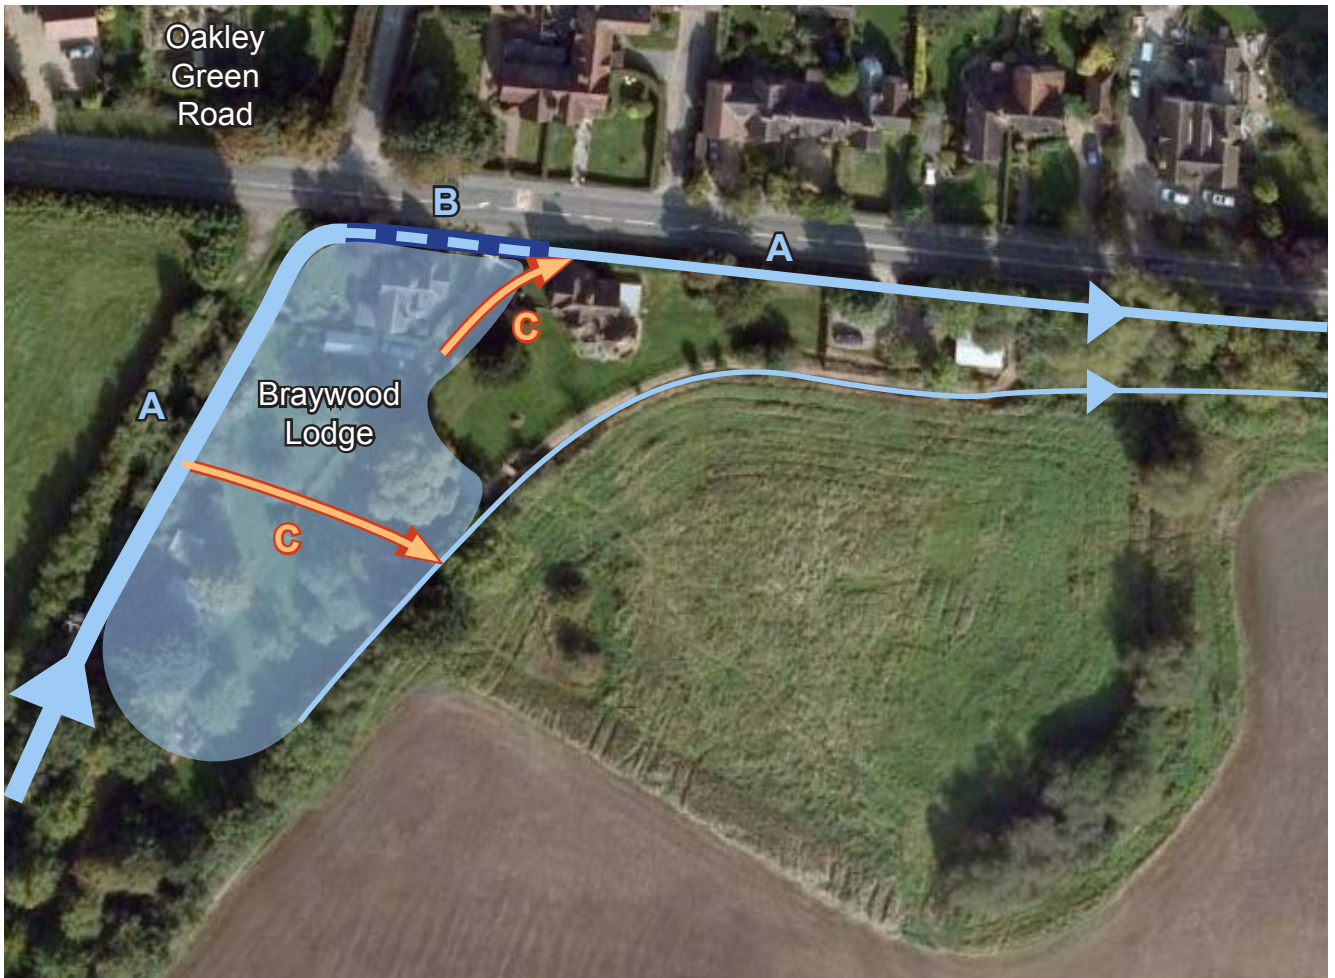
### 3 Braywood Lodge - Oakley Green Road

In 2011 volunteers cleared the ditches at (A) and Streetcare arranged jetting of pipes under the roadside verge at (B).

As far as we were able to tell this improved the situation and we thought we were safe to give a tick to this “wet spot”.

Unfortunately the resident informed us at an open meeting in February 2014 that the problem is not resolved and that there had once more been a lot of water on the driveway. So this “wet spot” was returned to Amber status.

Streetcare promised that the pipework running parallel with the road in the vicinity of Braywood Lodge would again be checked and cleaned. This is unlikely to remove the problem completely so at the next heavy rainfall event the site should be monitored and it may be necessary to recommend land drainage piping at (C).

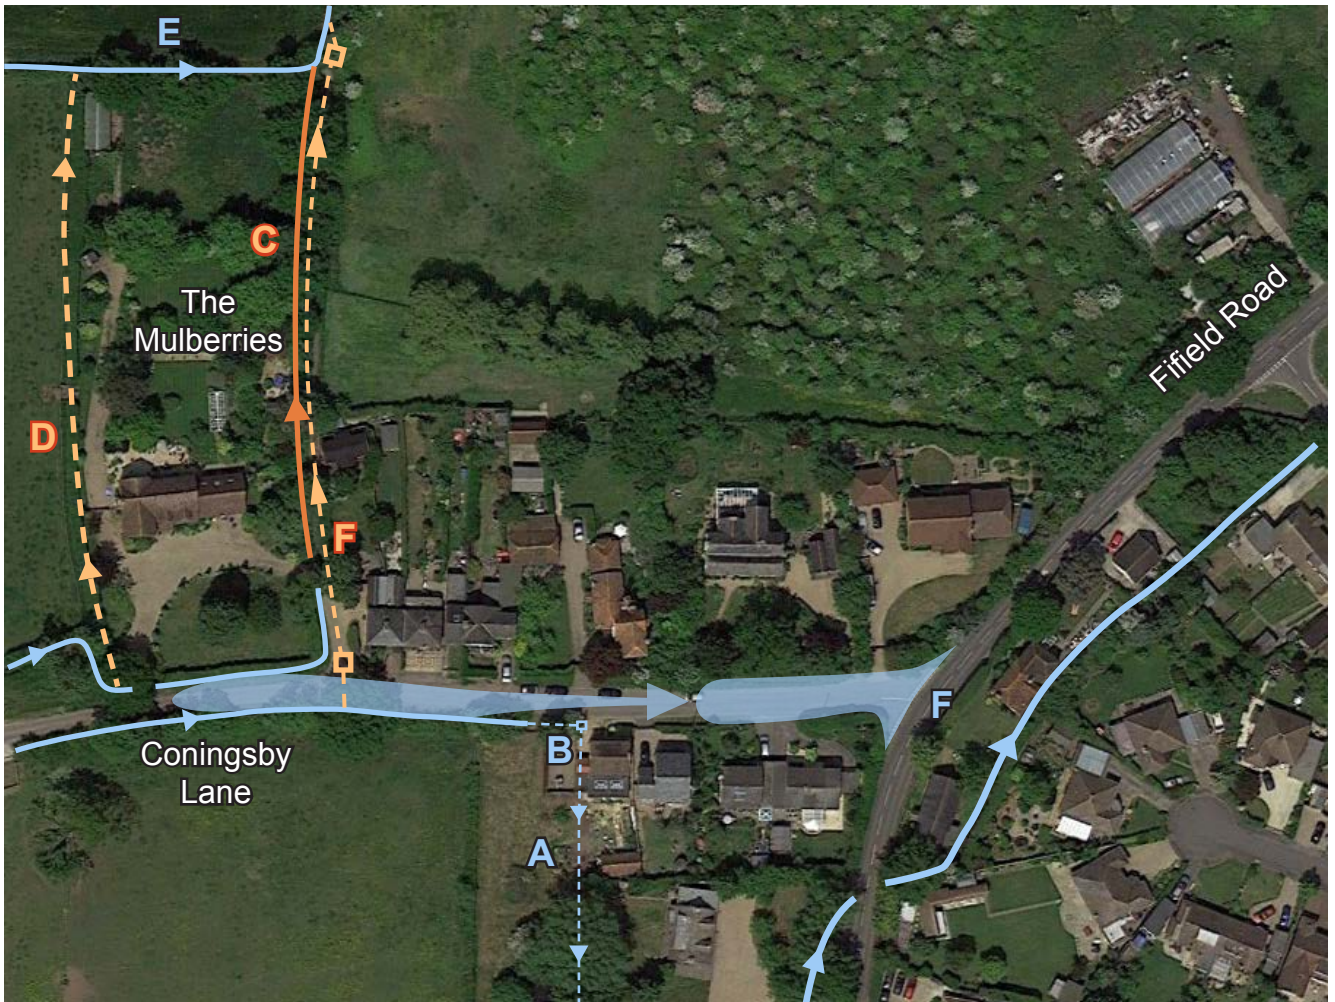
#### 4 Coningsby Lane shambles

Water flows eastward along the ditches on either side of Coningsby Lane. The ditch on the southern side of the Lane can only escape via a 6 inch pipe (A) into the grounds of Willow Creek to join water coming from the south to the culvert under the Fifield Road. In times of extreme weather this pipe can no longer handle the volume of water and the ditch backs up. Even The manhole cover (B) that allows this route to be inspected and cleared has recently been covered over by a new driveway.

On the northern side of the Lane the installation of a new driveway without a culvert when the Mulberries was built interrupted the flow along a ditch running north (C). This ditch has long since become silted up and overgrown. A ditch that used to run north along the eastern boundary of The Mulberries (D) to drain into the eastward flowing ditch (E) was piped and covered over many years ago and no longer appears to function at all.

So with only a single 6 inch escape route southward from this watery cul-de-sac there is an inevitable back-up that eventually forms the familiar frequent lake at the junction with the Fifield Road (F).

The most obvious improvement would be to re-instate the now defunct ditch (C) but for the last 15 years the historical existence of this route has been disputed by a local resident who objects to both the re-instatement of this original ditch and the clearance of the pipe (D). Although it is quite obvious that this ditch once existed and can be vouched for by residents from before the late 1980s Streetcare are reluctant to take action as long as a resident objects.

An alternative plan might be to install a culvert to a chamber and a pipe running north (F) down the centre of the footpath to another chamber and feeding from there into the ditch (E). This would bypass the security concerns and be far simpler to install. But whatever is to be done requires approval, cooperation, and commitment from Streetcare.

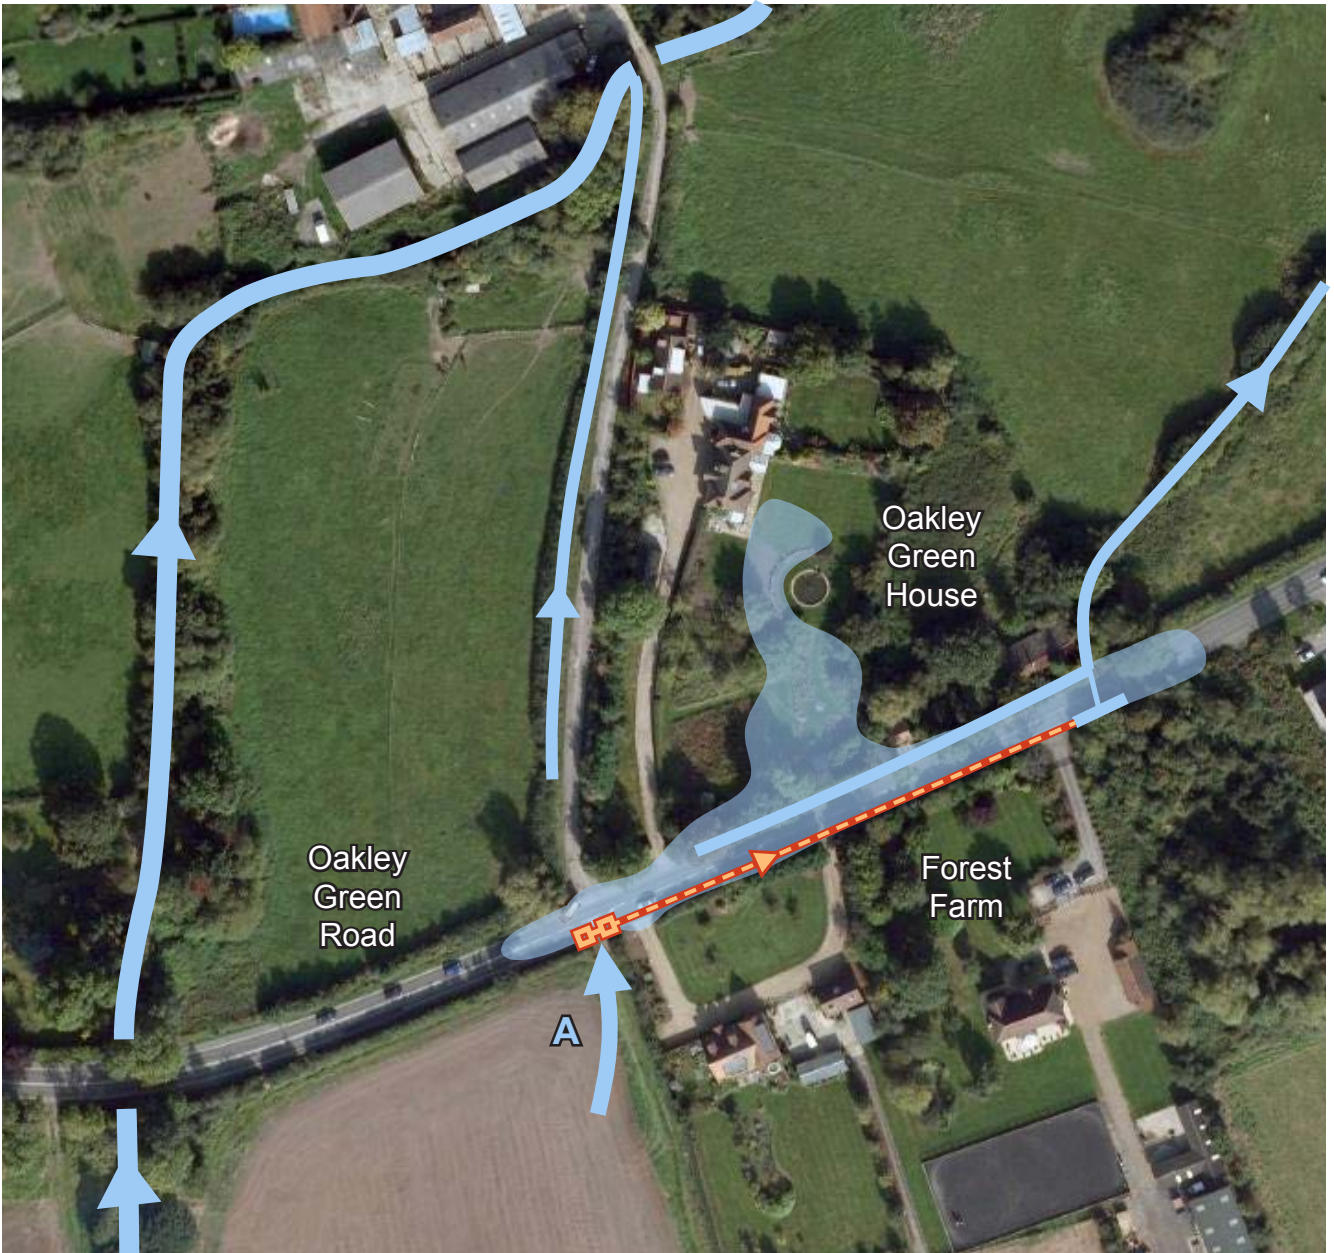
### 5 Oakley Green House and Forest Farm area - Oakley Green Road

Large amounts of water flowing out of the field gateway (A) used to cause the road east of this point to flood.

Streetcare carried out a reduced version of our recommendations and installed an extra 2 gullies in the gate entrance. This appears to have improved the situation and residents report that there has been no recurrence.

So until we hear otherwise this “wet spot” has been given green status.

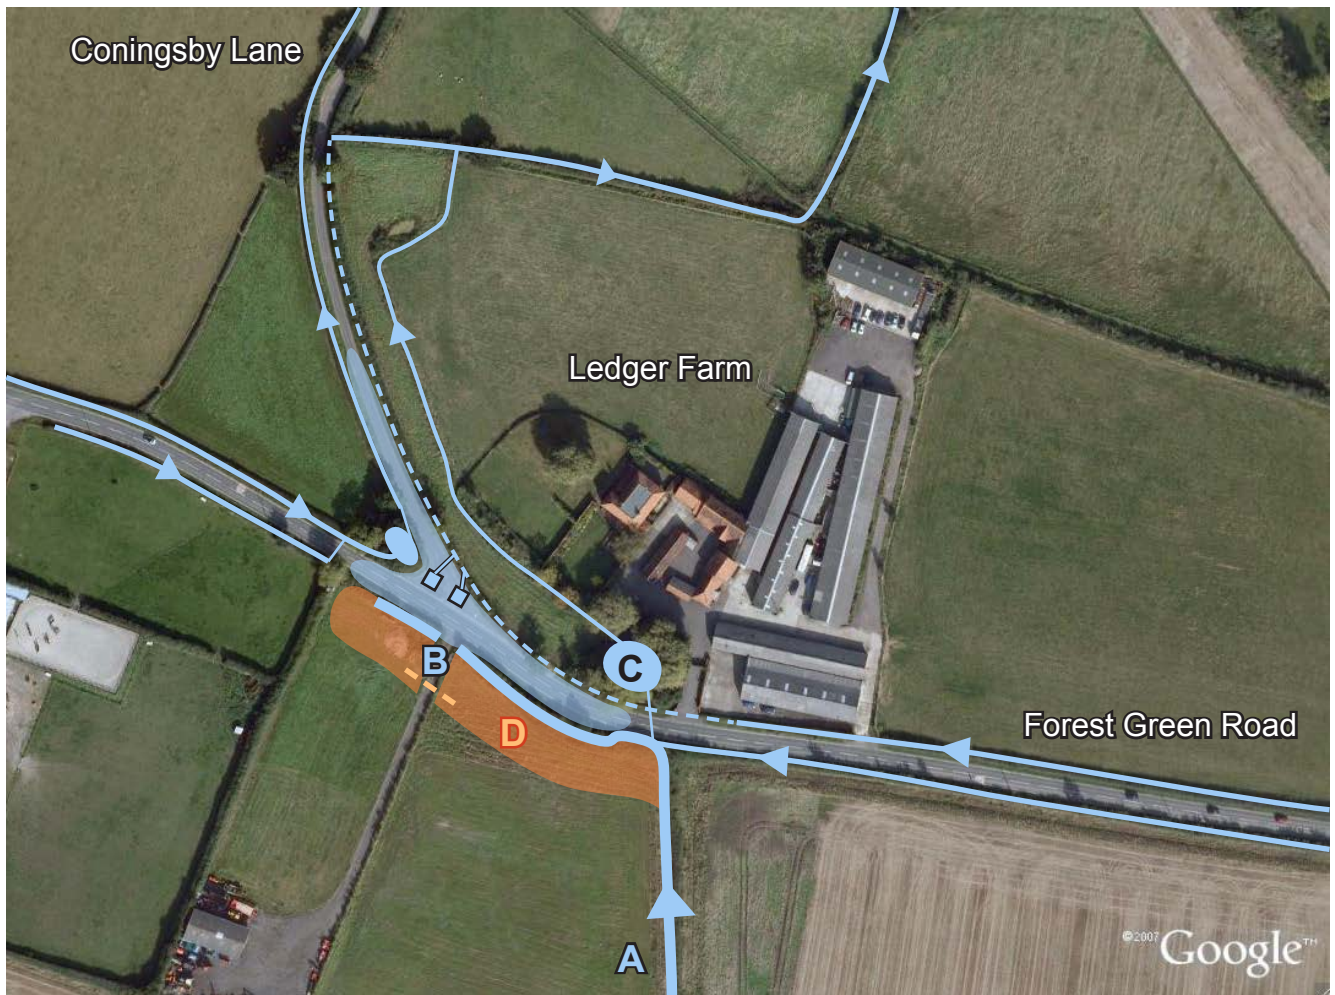
## 6 Ledger Farm - Coningsby Lane (south) and Forest Green Road

Water coming down **(A)** off the high ground of the Drift Road collects on either side of an entrance **(B)** on the south side of the Forest Green Road. When the valve for the pipe under the road into the pond at Ledger Farm **(C)** is closed water can only proceed northward by spilling out across Forest Green Road and down Coningsby Lane.

We have been unable to achieve anything here yet. Suggestions made in our original report are unlikely to find Local Government funding, at least not in the short term.

This would also have the beneficial effect of reducing the flow of water arriving at the north of Fifield in the front garden of Willow Creek (which used to be a pond) and trying to get under the road at the culvert there (which used to be a road bridge) to flow round the back of what was the old Chapel.

Perhaps the best that can be attempted in the short term is to encourage the landowner (Philip Mortimer ?) to agree to accept much more of a sump area **(D)** on the south side of the road so as to delay the progress of large quantities of water for a little longer.

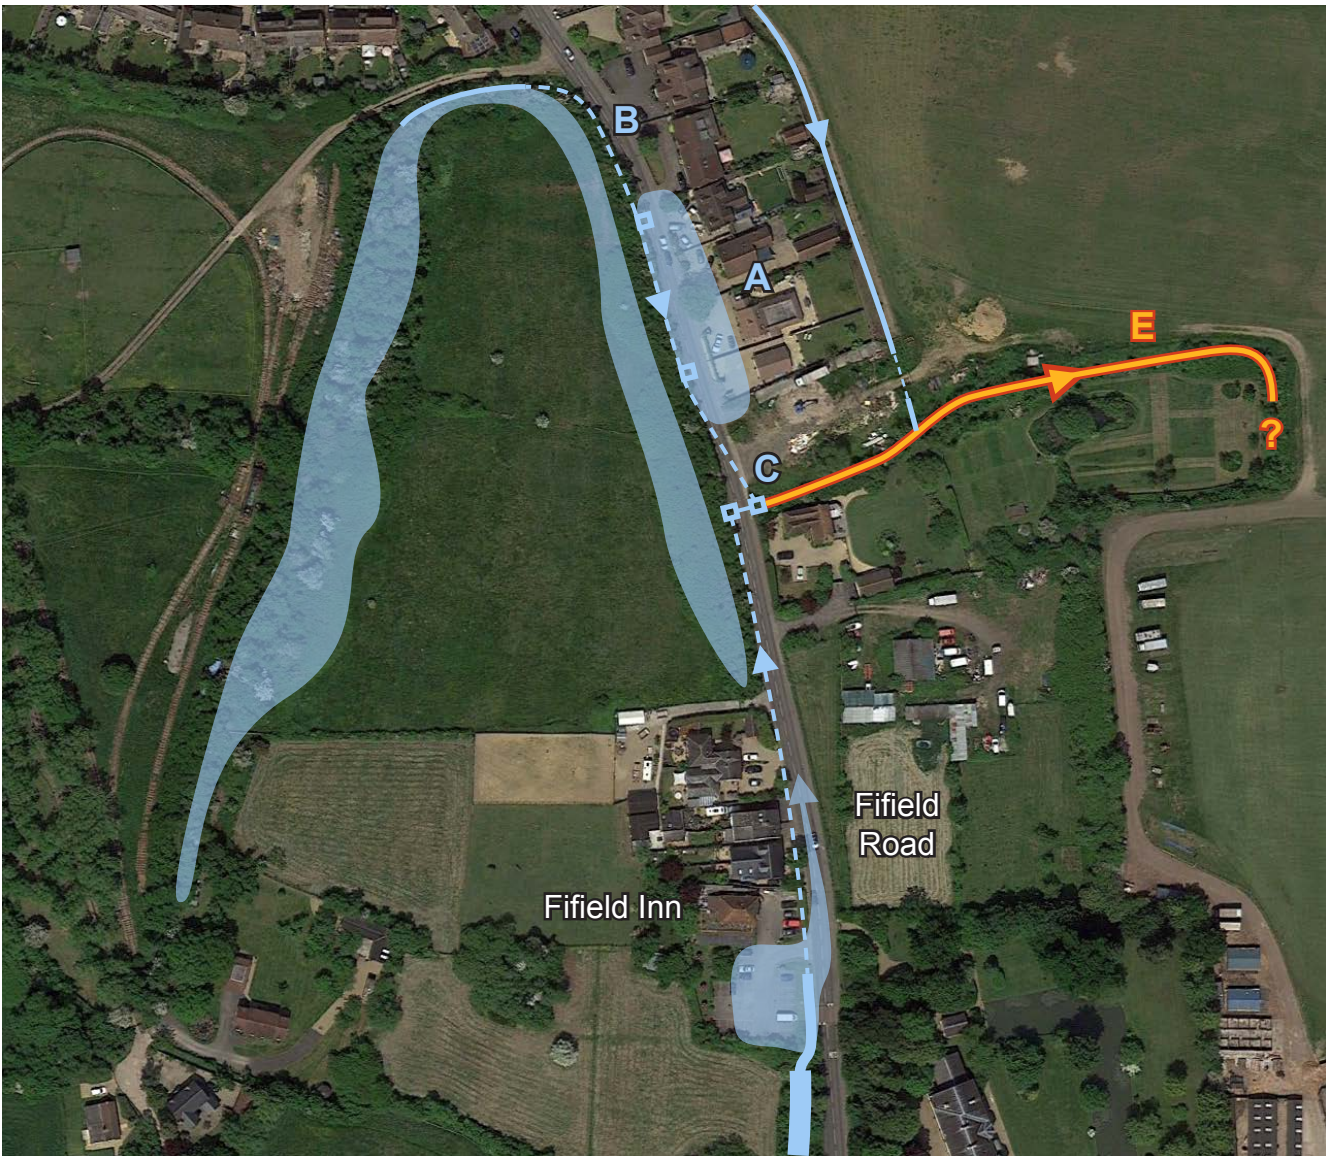
## 7 The Fifield Inn - Fifield Road (south)

In 2001, 2003-2004, and again on Saturday 4 January 2014 flooding at **A** forced residents to barricade their properties and deploy pumps. OGAFCA then made this the priority location as the most residents and properties were threatened. A site meeting on March 27 2015 led to a Streetcare investigation and within an hour a Streetcare team were clearing and jetting drains and gullies along this stretch. Contrary to expectations the gullies on the west side of the road did not extend away from the road at all but merely lead into the ditch, which was virtually non-existent anyway.

Streetcare's investigations led them to a decision to pipe the whole length from **B** to the chamber at **C** and renew roadside gullies and curbs. However, they said that the outflow from the chamber (**C**) flowing eastward beside the boundary of Garden Cottage along ditch **E** towards the Polo pitch needed to be cleaned out or the system would still back up. We wrote to the Landowner and a site meeting took place on Thursday July 17 2014. The landowner, Mr Bennett, met with us and Streetcare on site and agreed to clear the ditch.

At the end of October 2014 Streetcare carried out work and the new gullies now feed into this new pipe and from there under the road to the chamber. The contractors reported that the ditch towards the polo pitch still needed to be cleaned out or water would back up in the new pipe. Streetcare contacted the landowner again who promised to carry out the necessary maintenance. Unfortunately as far as we are aware this work has still not yet been done but this location has a GREEN status until wet weather shows if it is still deficient.

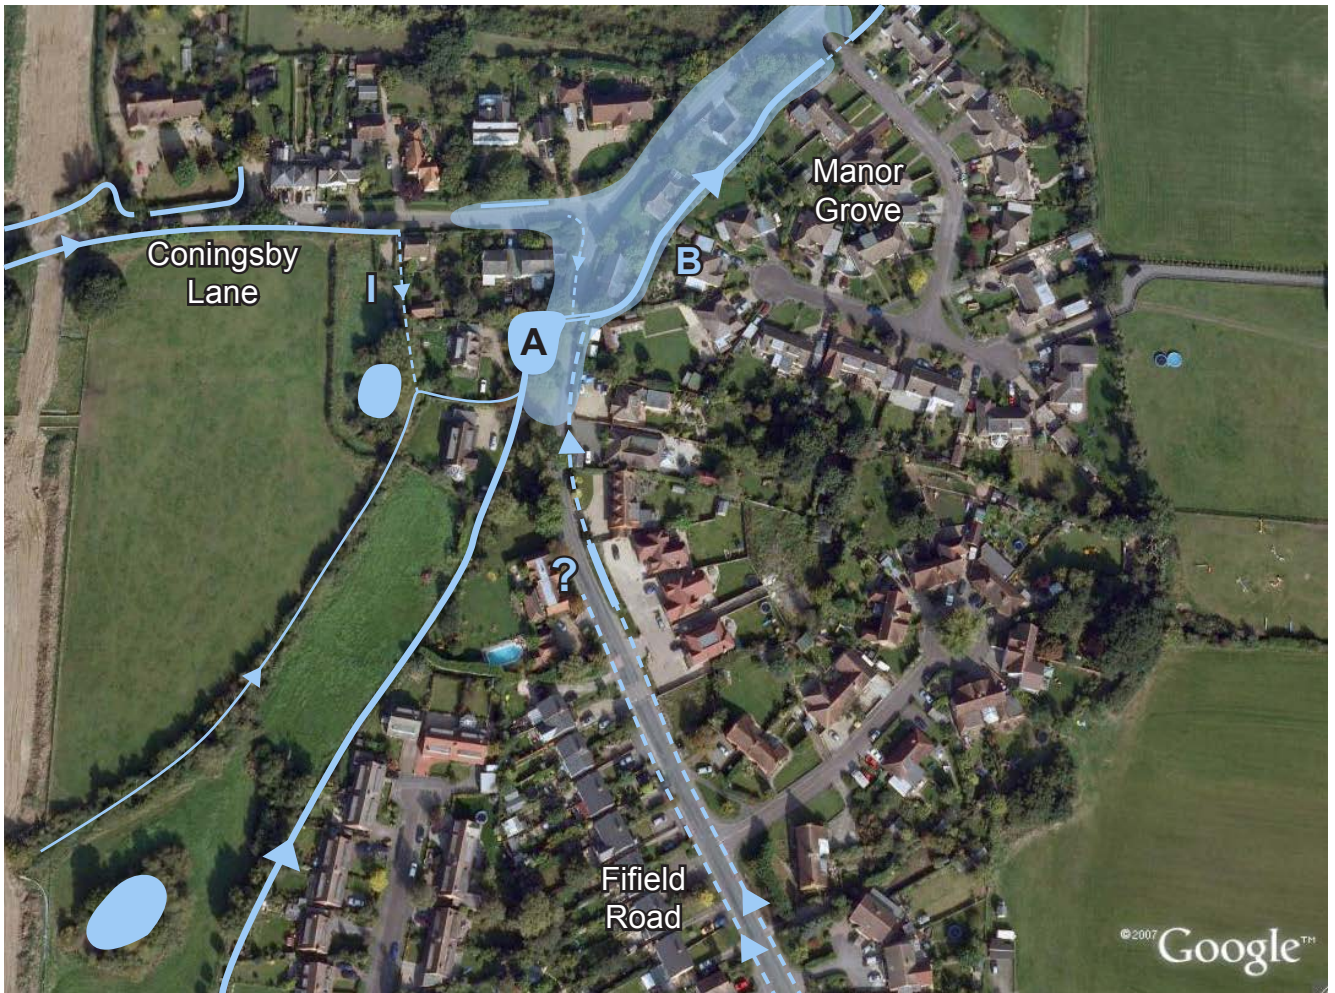
## 8 Culvert under road at Willow Creek - Fifield Road

Several drainage routes converge at a double culvert under the Fifield Road turning what is normally a stream through the front garden of *Willow Creek* into a large pond (A) in times of heavy rainfall. 60 years ago or more this really was a full time pond and there was a small road bridge allowing a substantial northward outflow (B).

At times of heavy rainfall this pinch point causes major flooding and as yet we have managed to achieve absolutely nothing that might improve the situation.

In fact it is very difficult to see how the onward flow from this point could be expanded to reduce the back-up. The route from what used to be the pond under the road via the culvert that used to be a road bridge and then the constrained channel behind the old chapel and the Old Cottage to the culvert under Manor Grove and onwards cannot realistically be usefully expanded.

The most obvious improvement to the onward flow of water for the whole area would be the installation of a major storm drain under the entire length of Fifield Road and on under the A308. But given the constraints of local government budgets this is clearly a fantasy.

When the rain stops and levels begin to drop excess water now clears pretty speedily, much more quickly than it ever used to. Probably the most practical approach is to investigate the possibility of delaying the arrival of all this water and spreading the flow over a longer period of time at a slower pace. This of course will in time require discussions with various landowners and we can hardly expect them to be keen on the idea of donating land to become a sump. It will also be necessary to consider how funding might be raised for this sort of work as it looks increasingly unlikely to be provided by local government.

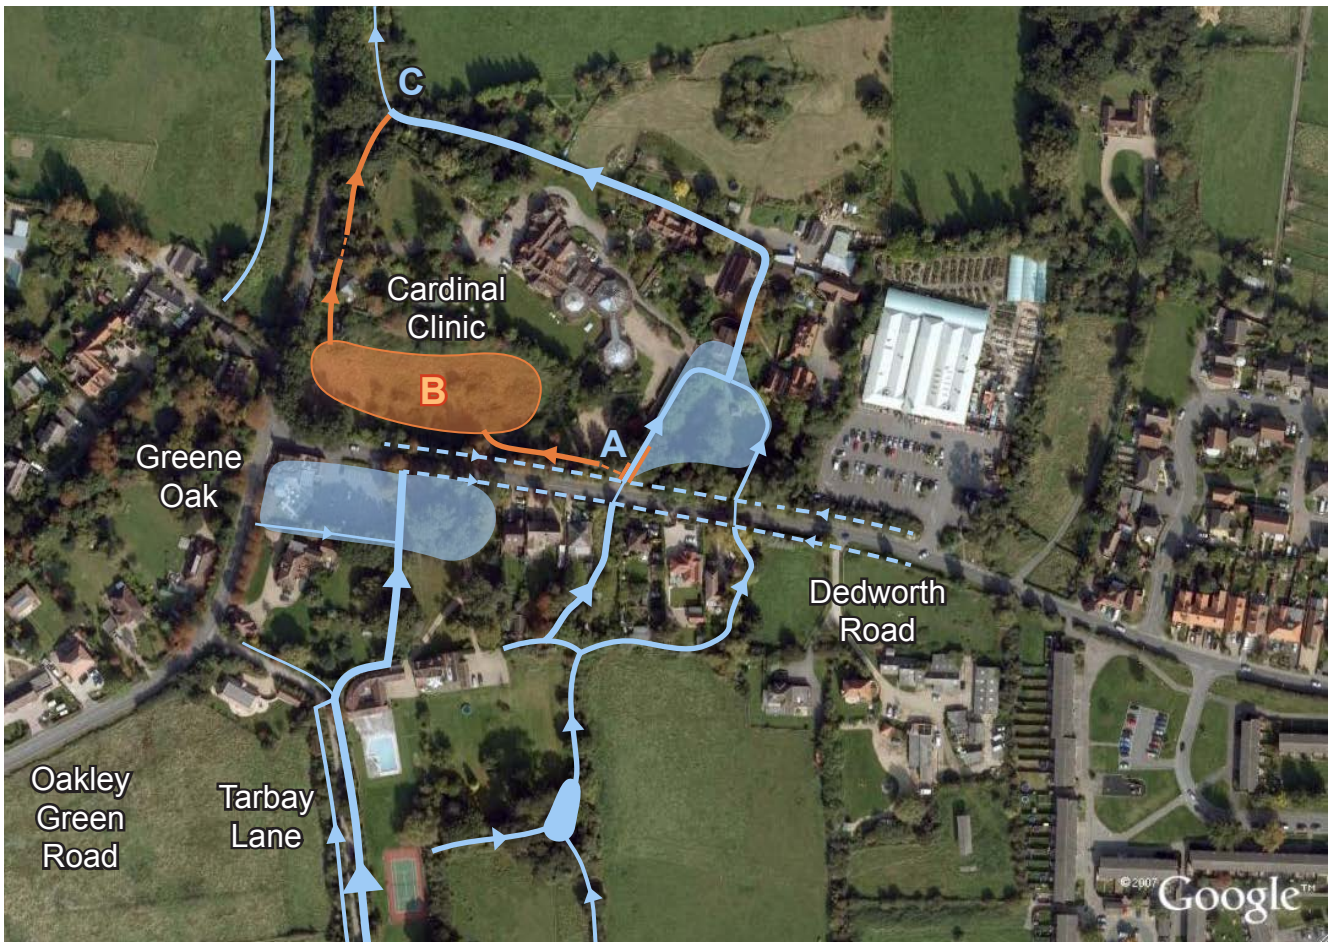
## 9 Cardinal & Hand Clinics - Oakley Green Road & Dedworth Road

From the relative high ground of Tarbay Lane water heads north towards the Thames taking various routes through the dwellings south of the Dedworth Road. Once it reaches Dedworth Road there is really no sensible onward route and it gushes into the car park of the Greene Oak and out from under the road into the grounds of The Cardinal Clinic (A) where the existing fairly substantial route through the site is often overwhelmed.

This is the most difficult of all the “wet spots” to deal with and we have been able to achieve absolutely nothing here. It is very disheartening that a Streetcare officer once said that although he had worked for RBWM for 5 years he was not aware of any flooding in this area. Really ?

Once rainfall abates water levels generally fall speedily - much more quickly than in the past. This would suggest that some work by Streetcare to maintain the onward flow has been beneficial. But it also suggests that there is probably little we can ask for to improve onward flow. A major detailed survey will be needed and technical propositions for major storm drain works under the roads to take the water more efficiently towards and under the A308 to the Thames and-or to try and hold water back to delay the flow. It seems very unlikely that funding for such a scale of work will ever be provided by local government.

The best possibility for a short term improvement for the Cardinal Clinic might be to constrain the pressured inflow at A so that it can no longer escape north east, and divert a percentage of it to a holding pond or small lake (B). This might be created on what appears to be unused or paddock land at the corner of Oakley Green and Dedworth Road. The outflow from here could be taken north to join the existing route at C.
