# the problem of flooding in **CONINGSBY LANE**

compiled by  
Rod Lord, Old Lodge Farm, Coningsby Lane, Fifield  
01628 627032 [rod@rodlord.com](mailto:rod@rodlord.com)

## **The problem of flooding in CONINGSBY LANE**

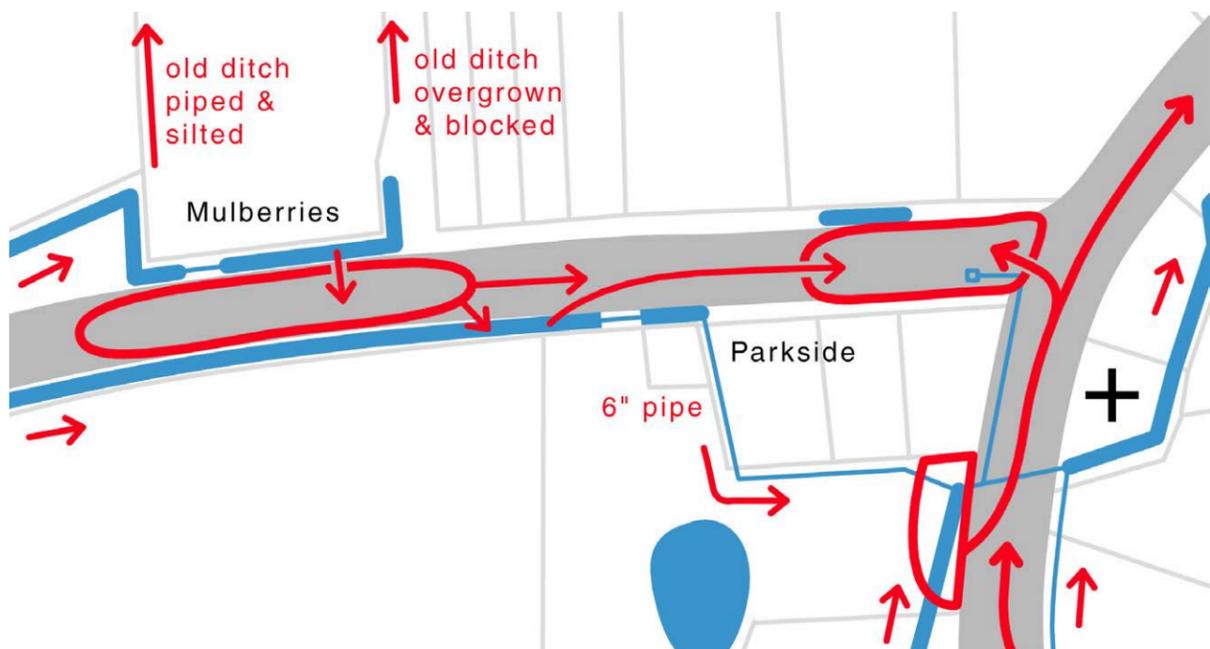
It doesn't take very much extra flow for the level of water trying to get under the Fifiel Road to rise above the 6” pipe from Coningsby Lane, and continue rising. The culvert begins to act like a flow-reduction valve, or a sluice gate in a dam. There comes a point where in-flow exceeds out-flow and a second sluice gate needs to be brought into play or the dam will overflow. This principle applies to both the culvert under the Fifiel Road and the 6” pipe from Coningsby Lane. Unfortunately there are no second sluice gates.

The dam with the smallest sluice gate (just a 6” diameter hole !) is the first to go. Water backing up in the Coningsby Lane ditch eventually runs out of sump volume and flows out onto the road and thence in a stream down the road to enlarge the lake at the junction. Water building up to get through the Fifiel Road Culvert also eventually flows onto the road where it joins water overflowing the “Hare and Hounds” ditch. At this point Fifiel road becomes a wide shallow river flowing north looking for exits from the road.

The first of these is of course into the lake already at the junction of Coningsby Lane. Once this is equalised it looks for roadside ditches...or houses...or the sewage system. The sewers back up and the ground water level rises beyond what is at the best of times only 20” or so below the surface. The first ditch capable of taking this flow is north of the Nursing Home, but there is more water flowing onto the road near here off the field and through the gate just south of the Biffa site.

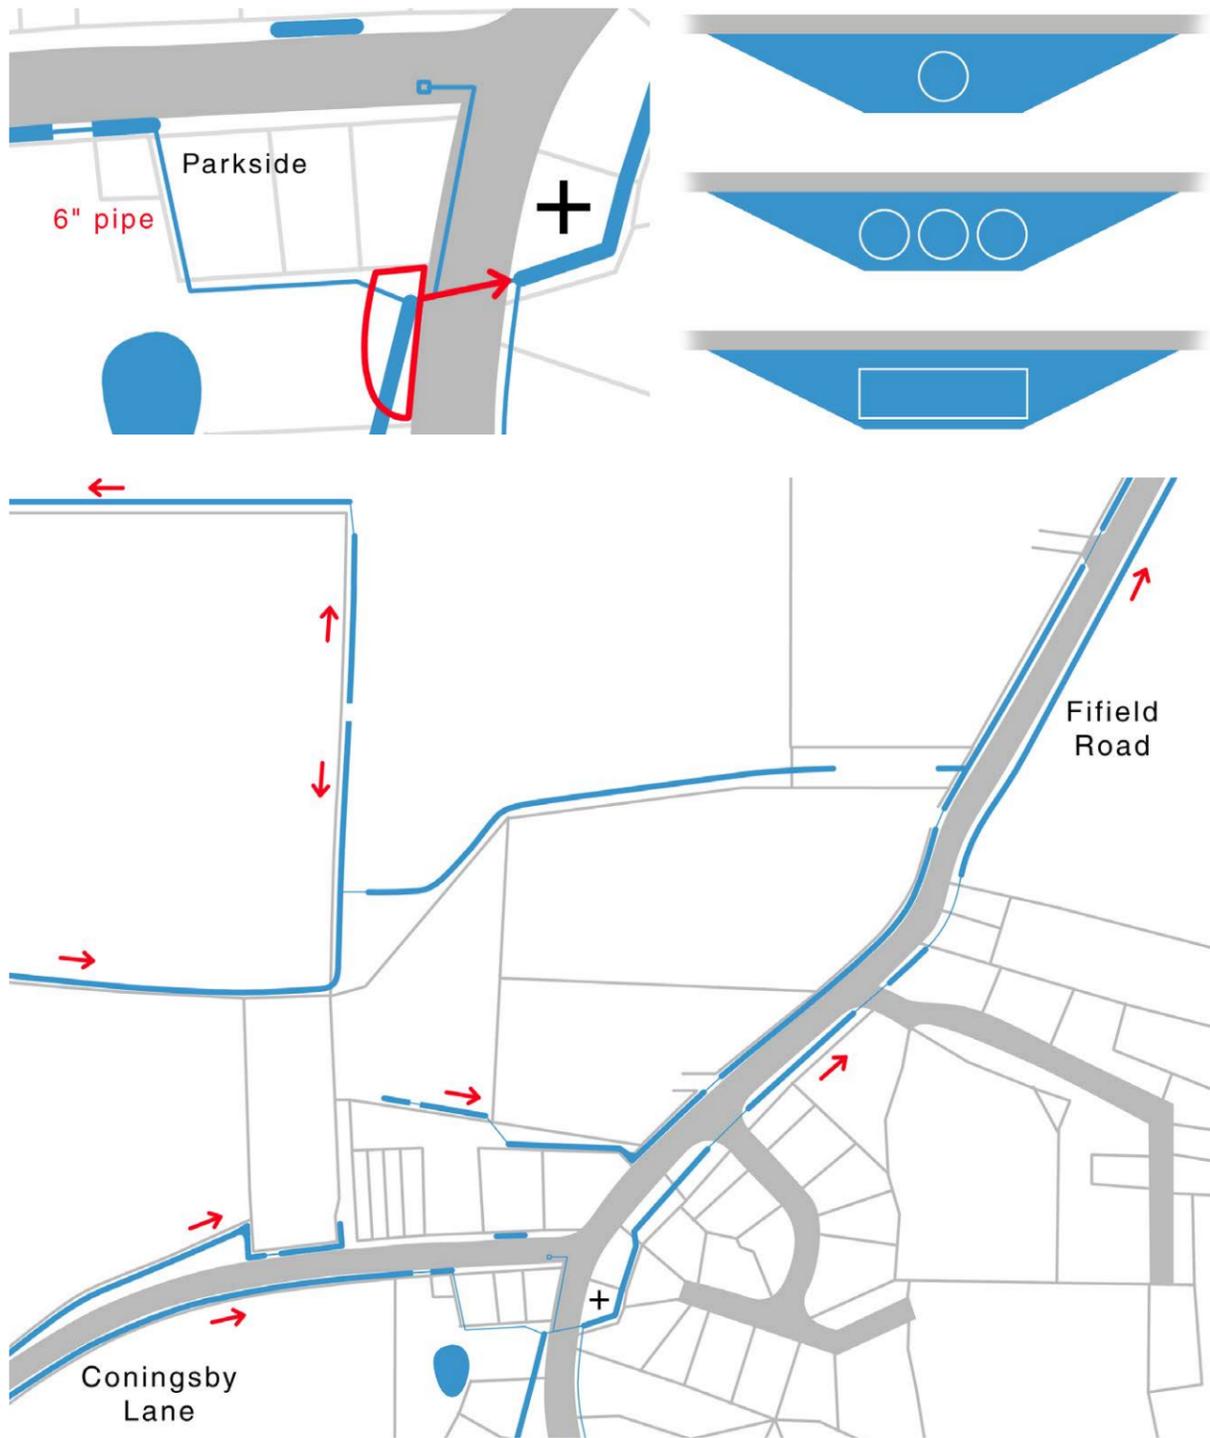
In the not too distant past attempts have been made to improve the drainage at the low point in Coningsby Lane at its junction with Fifield Road. This seems to amount to a gully in the road with a pipe leading to the culvert under Fifield Road. This works admirably in allowing the lake to drain away after the deluge is over and general levels subside.

Unfortunately in the early stages it contributes to the problem. As soon as demands begin to increase and levels start to rise this forms just another exit from the culvert. When the culvert is at full capacity it acts as a very efficient pressure release and water wells up to add to the first flow down the lane. Perhaps if some sort of simple valve or one-way flap had been incorporated this could have been avoided. Perhaps at some point it could still be done.

More recently attention has focused on clearing culverts and ditches. This is admirable and obviously essential. Under normal low rainfall conditions this will appear to work perfectly and where routes were actually blocked or partially blocked some problems will appear to go away.

BUT...the more you improve the flow BEFORE a dam the faster the level of the dam lake will rise...and however much you improve the route AFTER a dam the flow can only ever be what is allowed through the sluice gate. When the point is reached that in-flow exceeds out-flow you have an expanding and rising lake, and eventually it will flow over the dam wall.

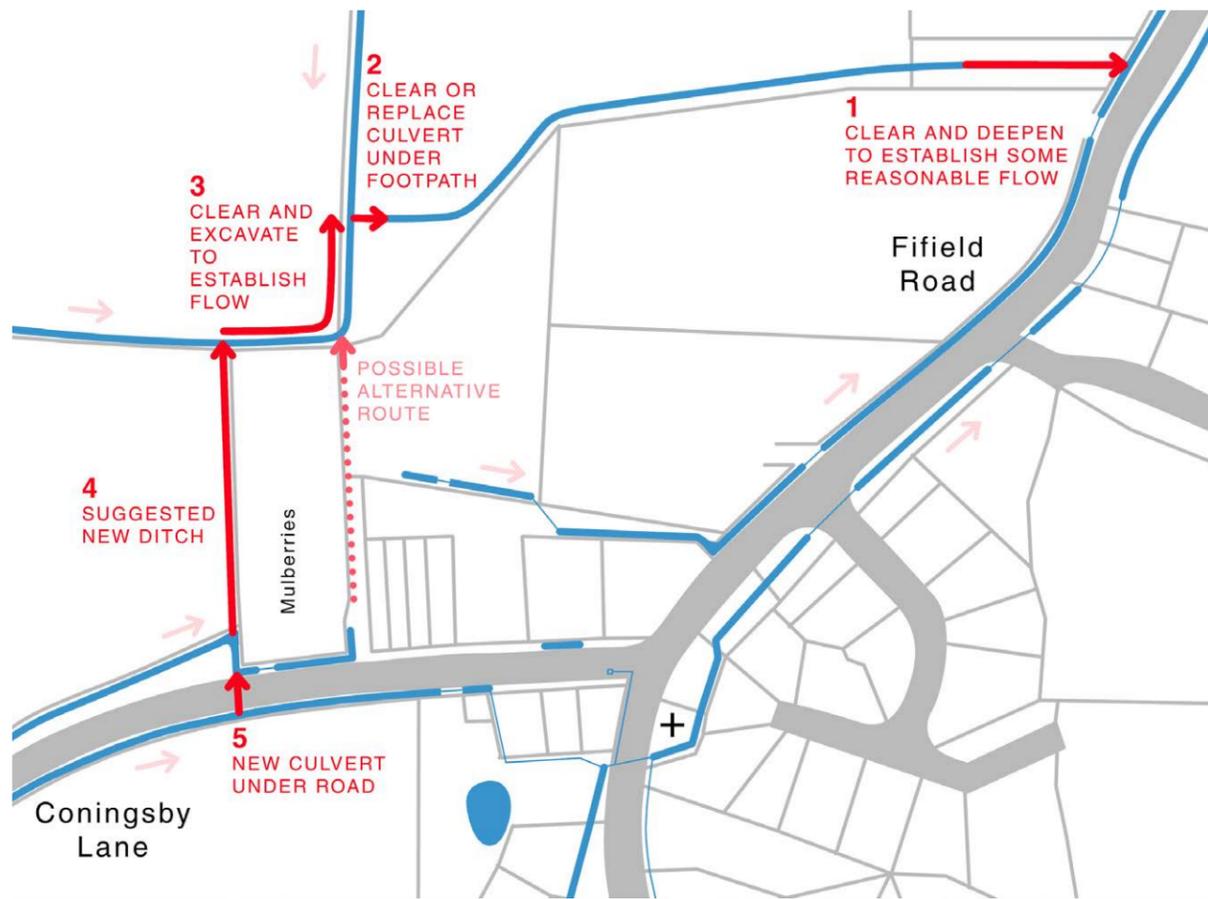
A sort of pond forms where the northern ditch in Coningsby Lane meets the western boundary of the "Mulberries". A new ditch could be taken from this point north to join the existing ditch running at the rear of the "Mulberries". The occupants of the "Mulberries" are worried that this would exacerbate the already serious problem with flooding they have along their northern boundary, so it would be important to be sure that the flow established between here and Fifield Road was sufficient not to back up. Hopefully the overall route would improve their situation rather than make it worse. It would certainly reduce the flooding in the south west corner of their land.

**1.** The old route out into the Fifield Road is currently blocked, partly because the ground rises slightly, but also simply from silting and general debris, including an old bath ! Comparative levels would need to be surveyed, but the dip is wide at this point and it should be possible to clear and excavate a central channel that at least is capable of allowing the top 2 or 3 inches of water an exit into the Fifield Road ditch. It might be necessary to support the sides to get sufficient depth, but an open ditch route would be far preferable to yet another pipe.

**2.** The existing pipe under the footpath would need to be cleared or replaced with multiple pipes or a railway sleeper "bridge".

**3.** The ditch on the northern boundary of the "Mulberries" would need to be cleared and excavated to re-establish a proper flow round to the footpath culvert.

**4.** We now need to get the Coningsby Lane water into this route. One option would be to reinstate the old defunct ditch beside the footpath east of the "Mulberries". Although it is possible to still see signs of this ditch it has been blocked for many years and a considerable amount of foliage is well established. Clearing and excavating this would entail a considerable amount of work, disruption and expense, and result in a rather stark aspect to this little lane. The ground seems to rise slightly to a point north of the main entrance to the "Mulberries", so excavation would need to be quite deep. A culvert would also need to be introduced under the main entrance to the "Mulberries", and if there is one under the other entrance that would need also to be cleared.. This would introduce yet another two potential bottlenecks which would have to be constantly maintained.

**5.** There would now be a route for the water on the north side of the Lane that currently has none at all. But there would still be large volumes of water flowing down the south side. It would be ideal if we could allow an exit north from this ditch by the route just described above. This would require taking a pipe (or rather 2 or even 3 pipes because of the small vertical dimensions involved) under Coningsby Lane.
