Drainage Overview
Updated October 2023

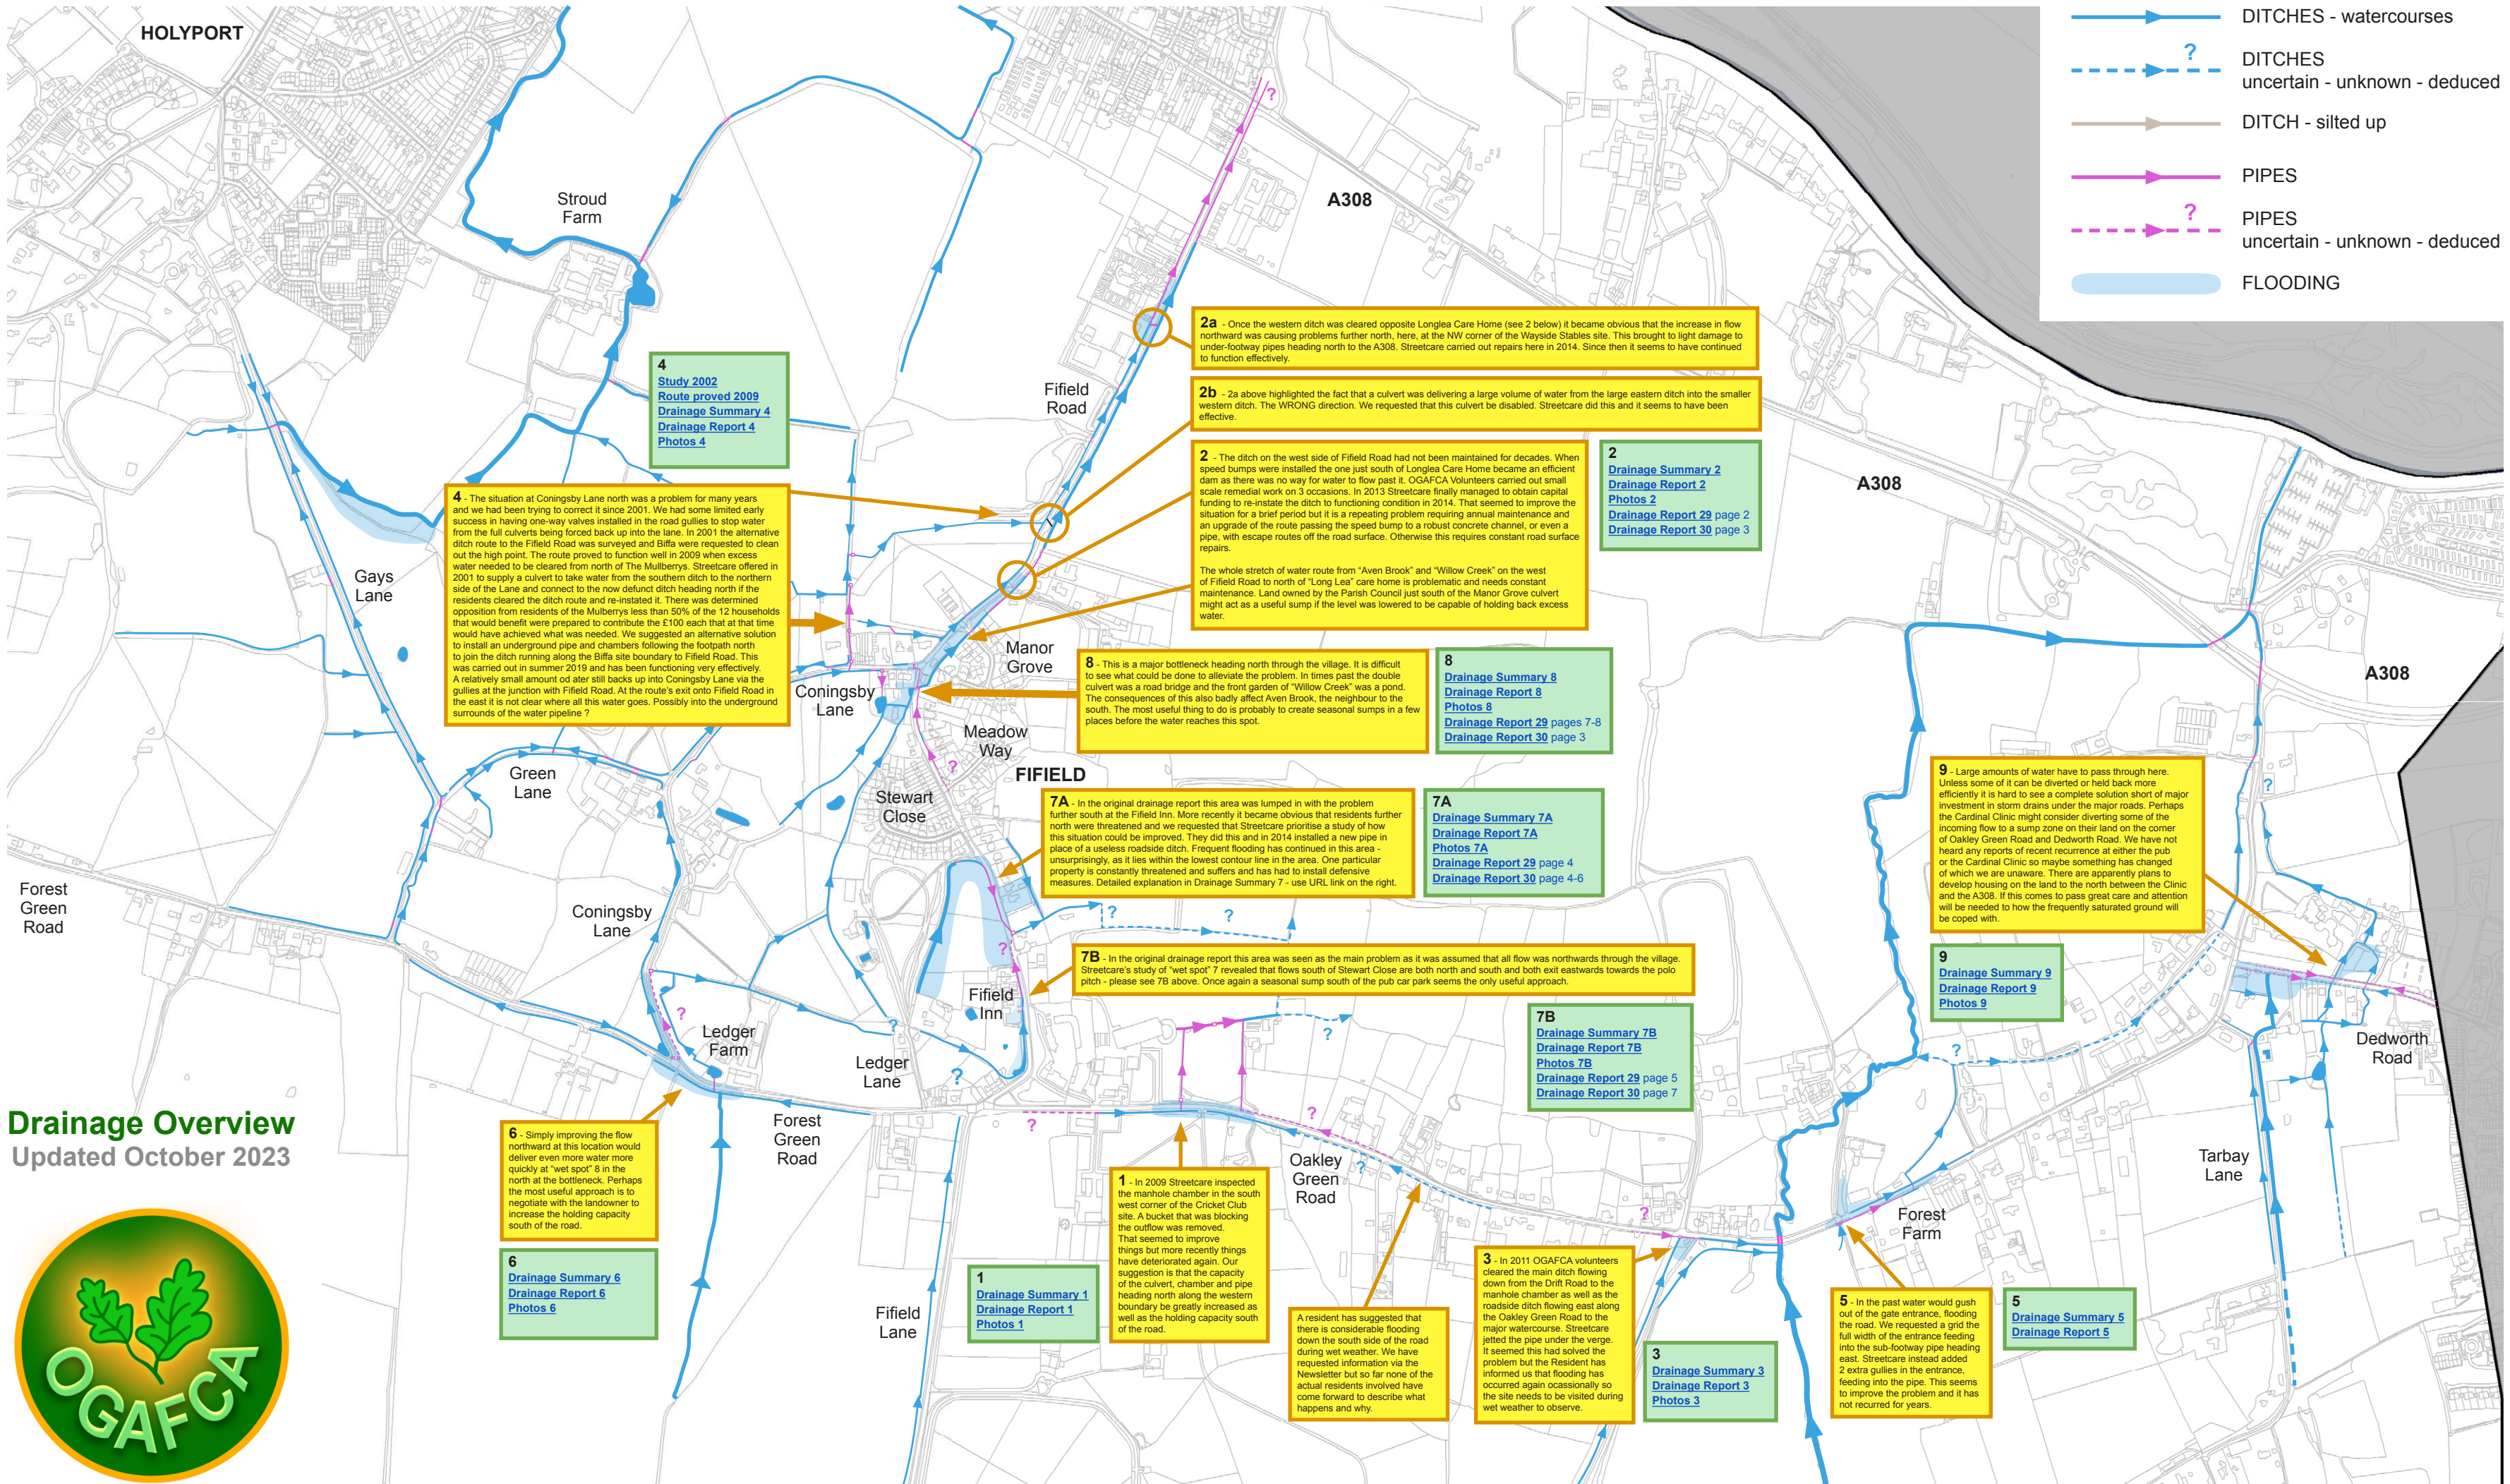
- 4** - Study 2002
Route proved 2009
Drainage Summary 4
Drainage Report 4
Photos 4
- 4** - The situation at Coningsby Lane north was a problem for many years and we had been trying to correct it since 2001. We had some limited early success in having one-way valves installed in the road gullies to stop water from the full culverts being forced back up into the lane. In 2001 the alternative ditch route to the Fifield Road was surveyed and Biffa were requested to clean out the high point. The route proved to function well in 2009 when excess water needed to be cleared from north of The Mulberrys. Streetcare offered in 2001 to supply a culvert to take water from the southern ditch to the northern side of the Lane and connect to the now defunct ditch heading north if the residents cleared the ditch route and re-instated it. There was determined opposition from residents of the Mulberrys less than 50% of the 12 households that would benefit were prepared to contribute the £100 each that at that time would have achieved what was needed. We suggested an alternative solution to install an underground pipe and chambers following the footpath north to join the ditch running along the Biffa site boundary to Fifield Road. This was carried out in summer 2019 and has been functioning very effectively. A relatively small amount of water still backs up into Coningsby Lane via the gullies at the junction with Fifield Road. At the route's exit onto Fifield Road in the east it is not clear where all this water goes. Possibly into the underground surrounds of the water pipeline?

- 2a** - Once the western ditch was cleared opposite Longlea Care Home (see 2 below) it became obvious that the increase in flow northward was causing problems further north, here, at the NW corner of the Wayside Stables site. This brought to light damage to under-footway pipes heading north to the A308. Streetcare carried out repairs here in 2014. Since then it seems to have continued to function effectively.

- 2b** - 2a above highlighted the fact that a culvert was delivering a large volume of water from the large eastern ditch into the smaller western ditch. The WRONG direction. We requested that this culvert be disabled. Streetcare did this and it seems to have been effective.

- 2** - The ditch on the west side of Fifield Road had not been maintained for decades. When speed bumps were installed the one just south of Longlea Care Home became an efficient dam as there was no way for water to flow past it. OGAFCA Volunteers carried out small scale remedial work on 3 occasions. In 2013 Streetcare finally managed to obtain capital funding to re-instate the ditch to functioning condition in 2014. That seemed to improve the situation for a brief period but it is a repeating problem requiring annual maintenance and an upgrade of the route passing the speed bump to a robust concrete channel, or even a pipe, with escape routes off the road surface. Otherwise this requires constant road surface repairs.

- 2** - Drainage Summary 2
Drainage Report 2
Photos 2
Drainage Report 29 page 2
Drainage Report 30 page 3
- The whole stretch of water route from "Aven Brook" and "Willow Creek" on the west of Fifield Road to north of "Long Lea" care home is problematic and needs constant maintenance. Land owned by the Parish Council just south of the Manor Grove culvert might act as a useful sump if the level was lowered to be capable of holding back excess water.

- 8** - This is a major bottleneck heading north through the village. It is difficult to see what could be done to alleviate the problem. In times past the double culvert was a road bridge and the front garden of "Willow Creek" was a pond. The consequences of this also badly affect Aven Brook, the neighbour to the south. The most useful thing to do is probably to create seasonal sumps in a few places before the water reaches this spot.

- 8** - Drainage Summary 8
Drainage Report 8
Photos 8
Drainage Report 29 pages 7-8
Drainage Report 30 page 3
- 7A** - In the original drainage report this area was lumped in with the problem further south at the Fifield Inn. More recently it became obvious that residents further north were threatened and we requested that Streetcare prioritise a study of how this situation could be improved. They did this and in 2014 installed a new pipe in place of a useless roadside ditch. Frequent flooding has continued in this area - unsurprisingly, as it lies within the lowest contour line in the area. One particular property is constantly threatened and suffers and has had to install defensive measures. Detailed explanation in Drainage Summary 7 - use URL link on the right.

- 7A** - Drainage Summary 7A
Drainage Report 7A
Photos 7A
Drainage Report 29 page 4
Drainage Report 30 page 4-6
- 7B** - In the original drainage report this area was seen as the main problem as it was assumed that all flow was northwards through the village. Streetcare's study of "wet spot" 7 revealed that flows south of Stewart Close are both north and south and both exit eastwards towards the polo pitch - please see 7B above. Once again a seasonal sump south of the pub car park seems the only useful approach.

- 7B** - Drainage Summary 7B
Drainage Report 7B
Photos 7B
Drainage Report 29 page 5
Drainage Report 30 page 7
- 9** - Large amounts of water have to pass through here. Unless some of it can be diverted or held back more efficiently it is hard to see a complete solution short of major investment in storm drains under the major roads. Perhaps the Cardinal Clinic might consider diverting some of the incoming flow to a sump zone on their land on the corner of Oakley Green Road and Dedworth Road. We have not heard any reports of recent recurrence at either the pub or the Cardinal Clinic so maybe something has changed of which we are unaware. There are apparently plans to develop housing on the land to the north between the Clinic and the A308. If this comes to pass great care and attention will be needed to how the frequently saturated ground will be coped with.

- 9** - Drainage Summary 9
Drainage Report 9
Photos 9
- 6** - Simply improving the flow northward at this location would deliver even more water more quickly at "wet spot" 8 in the north at the bottleneck. Perhaps the most useful approach is to negotiate with the landowner to increase the holding capacity south of the road.

- 6** - Drainage Summary 6
Drainage Report 6
Photos 6
- 1** - In 2009 Streetcare inspected the manhole chamber in the south west corner of the Cricket Club site. A bucket that was blocking the outflow was removed. That seemed to improve things but more recently things have deteriorated again. Our suggestion is that the capacity of the culvert, chamber and pipe heading north along the western boundary be greatly increased as well as the holding capacity south of the road.

- 1** - Drainage Summary 1
Drainage Report 1
Photos 1
- A resident has suggested that there is considerable flooding down the south side of the road during wet weather. We have requested information via the Newsletter but so far none of the actual residents involved have come forward to describe what happens and why.

- 3** - In 2011 OGAFCA volunteers cleared the main ditch flowing down from the Drift Road to the manhole chamber as well as the roadside ditch flowing east along the Oakley Green Road to the major watercourse. Streetcare jettied the pipe under the verge. It seemed this had solved the problem but the Resident has informed us that flooding has occurred again occasionally so the site needs to be visited during wet weather to observe.

- 3** - Drainage Summary 3
Drainage Report 3
Photos 3
- 5** - In the past water would gush out of the gate entrance, flooding the road. We requested a grid the full width of the entrance feeding into the sub-footway pipe heading east. Streetcare instead added 2 extra gullies in the entrance, feeding into the pipe. This seems to improve the problem and it has not recurred for years.
