Another wet day in Fifield - update 30

Report on Heading South in Fifield on Friday 18 June 2021

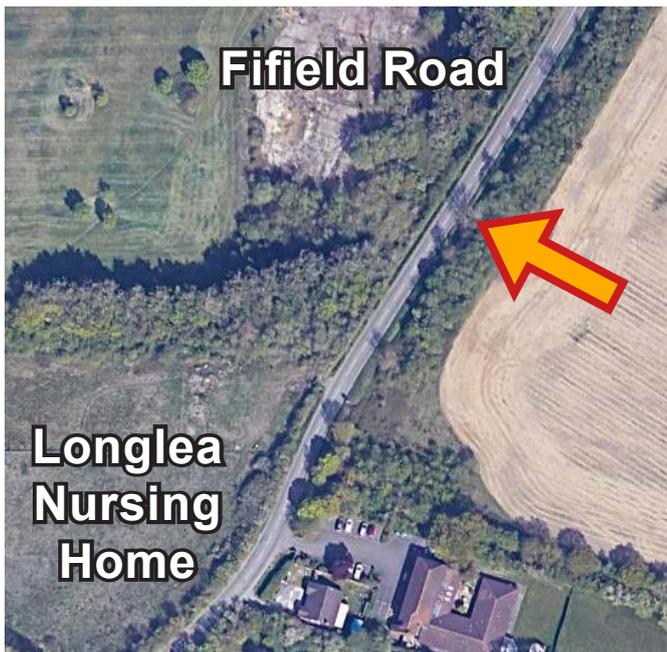
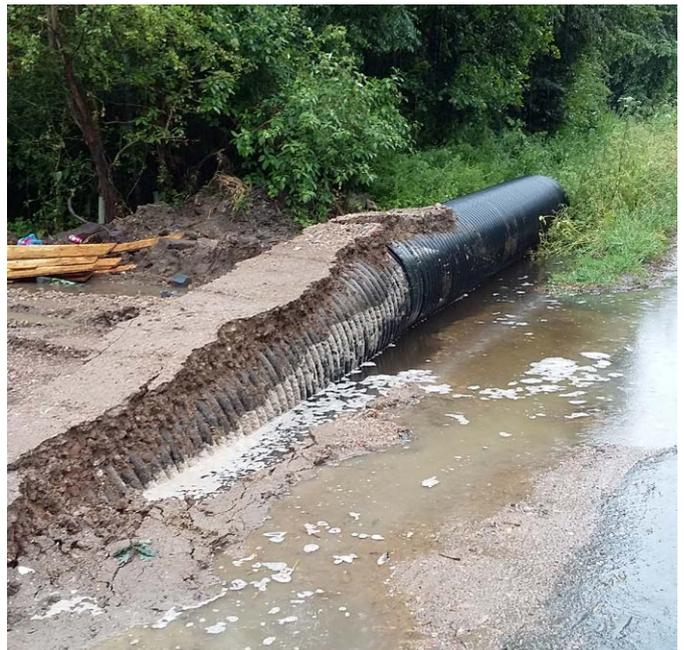
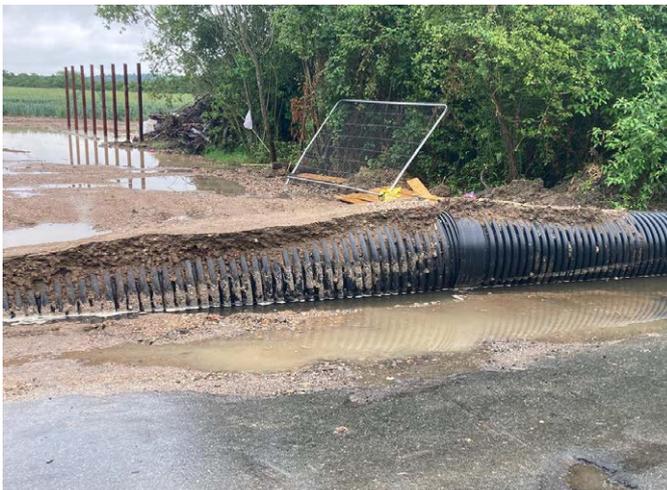
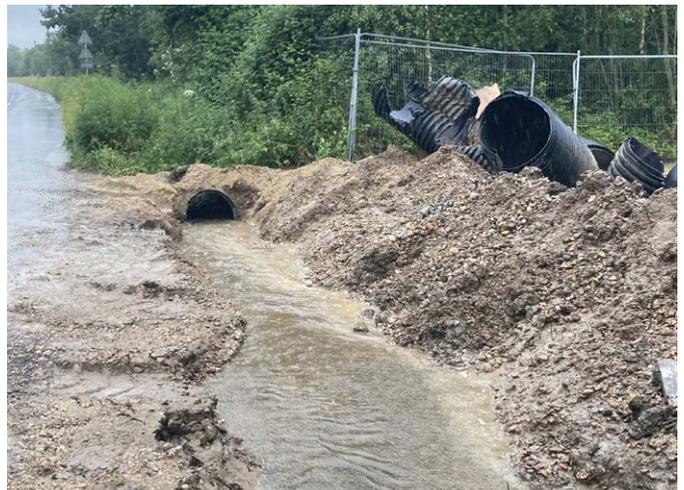
Phoenix Gym - proposed entrance

Local Residents had been expressing much concern about several aspects of the work going on at this site. When RBWM investigated it turned out that not only did the traffic lights have no permission but that there had also been no planning application for the temporary building they were planning to erect. Phoenix management said they thought "*it was worth the risk*" ! **OGAFCA** pointed out that the ditch crossing and entrance that was created bore no relationship whatsoever to the approved planning drawings nor any compliance with planning consent conditions. Contractors were instructed to stop work but somehow the pipe they had installed in the ditch got kicked up at one end and consequently blocked the flow heading north out of the village. As the water gradually backed-up southwards into the village the pipe had to be cut out to reinstate the flow.

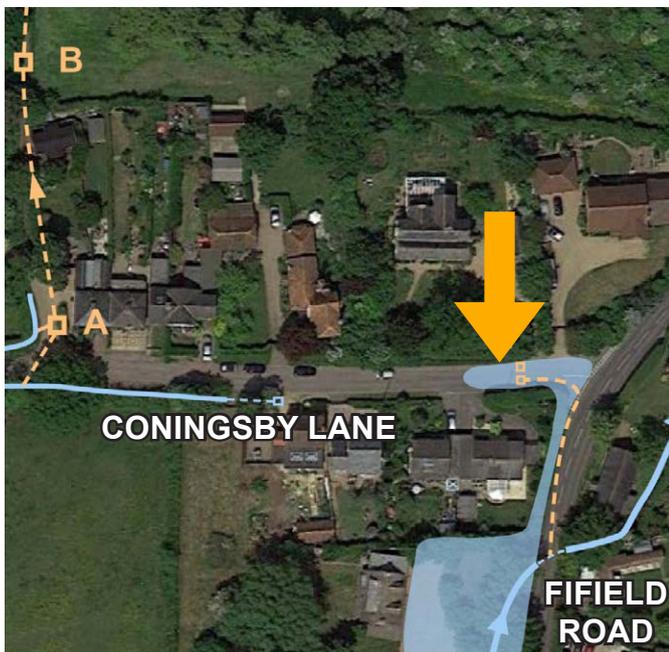
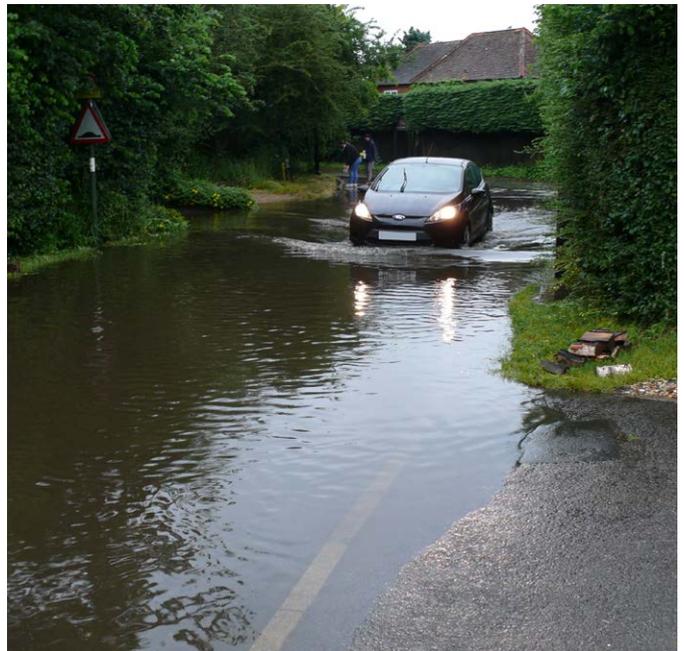
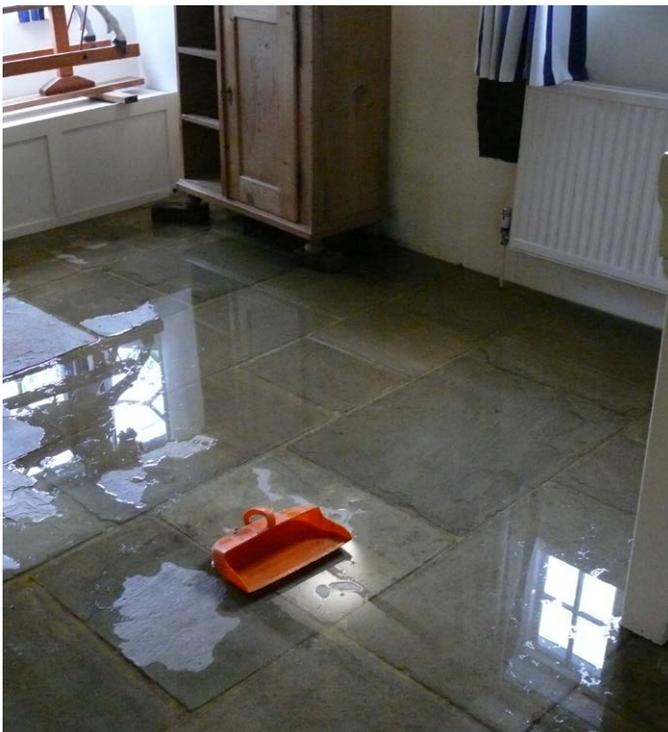
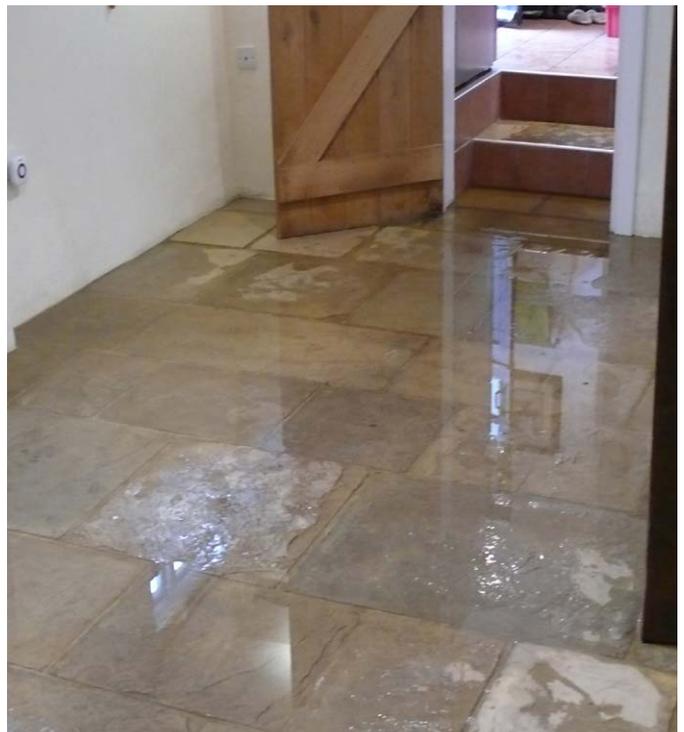
Coningsby Lane - “wet spot” 4

This “Wet Spot” has benefited hugely from the installation of the new drainage route heading north but the problems have not entirely gone away. Although water no longer gushes down the road to join and enlarge the lake that forms at the junction with Fifield Road water still collects at this low point. Until proved otherwise it is assumed that when the culvert further south is at capacity the pressure causes water to back up into the lane via 2 gullies. The route from these gullies to the culvert is supposed to have one-way flap valves and these are probably silted open. We will discover if this theory is correct when this route gets jetted. Despite the new route heading north there is still sufficient pressure in the groundwater in this area to force water up through the floor of a nearby property. Thankfully this was not as bad as it was in 2001 when 5 inches of water covered the floor. The assumption is that the new route has helped to relieve the groundwater pressure.

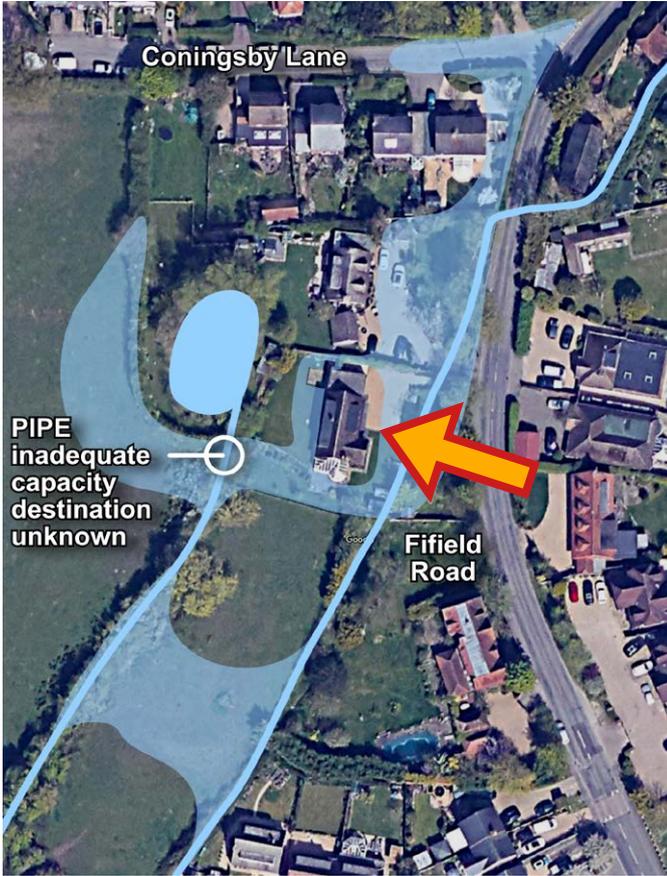
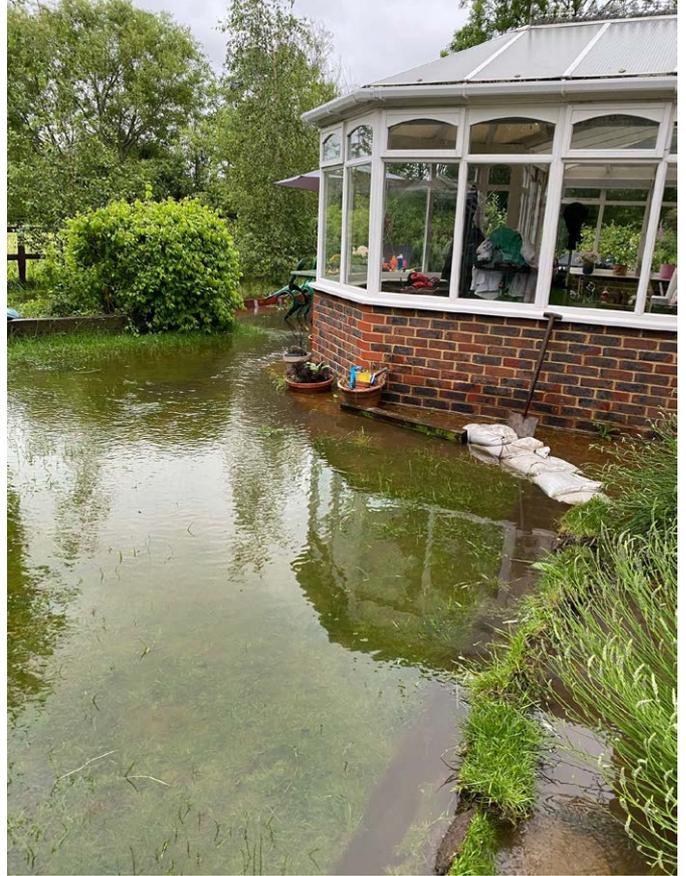
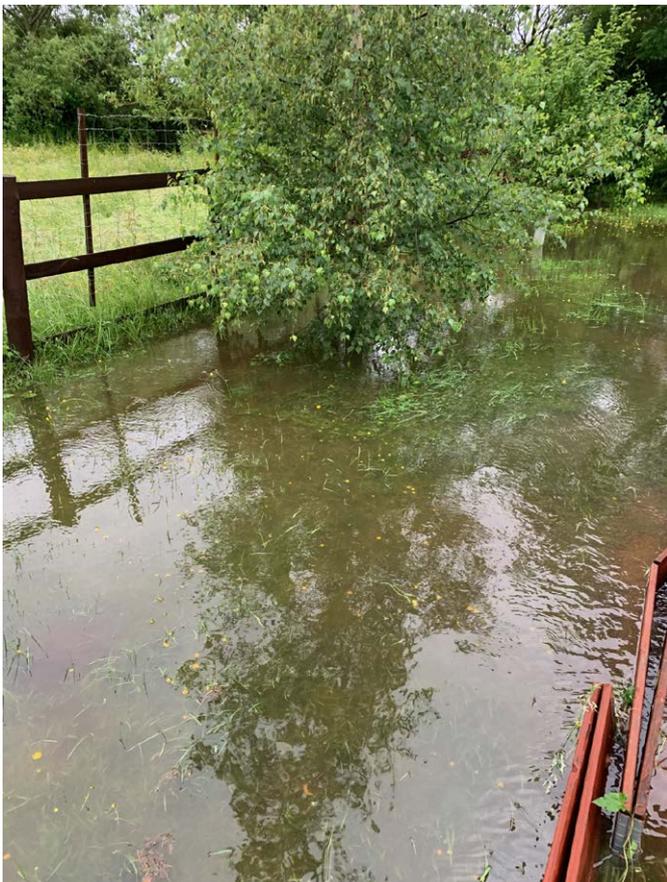
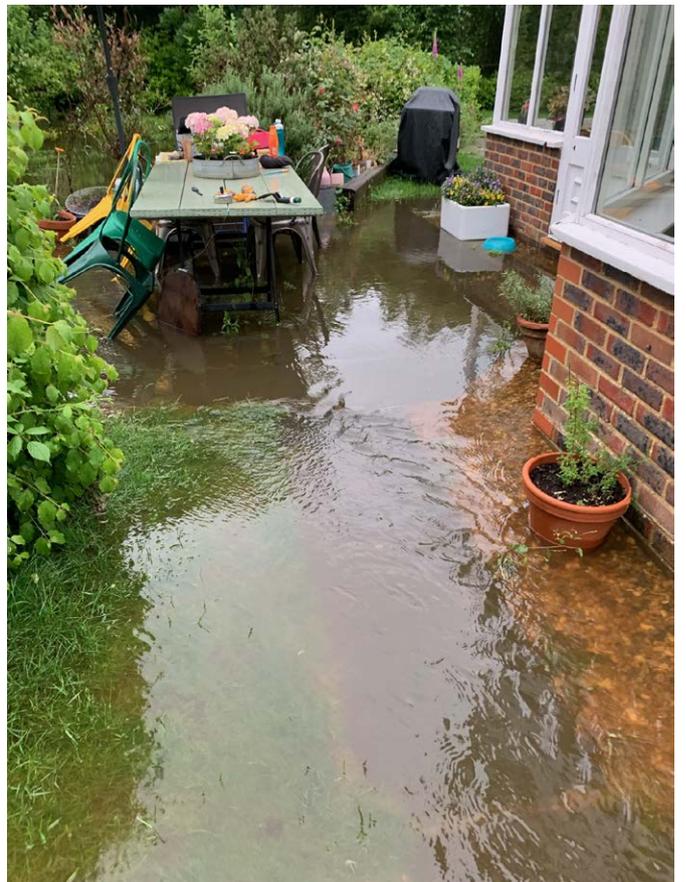
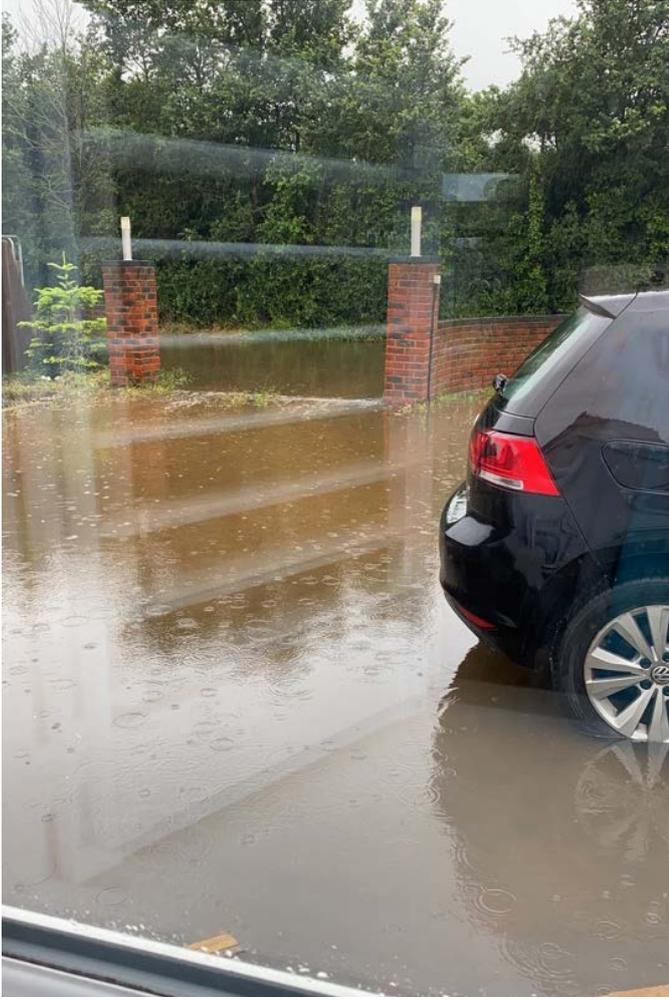
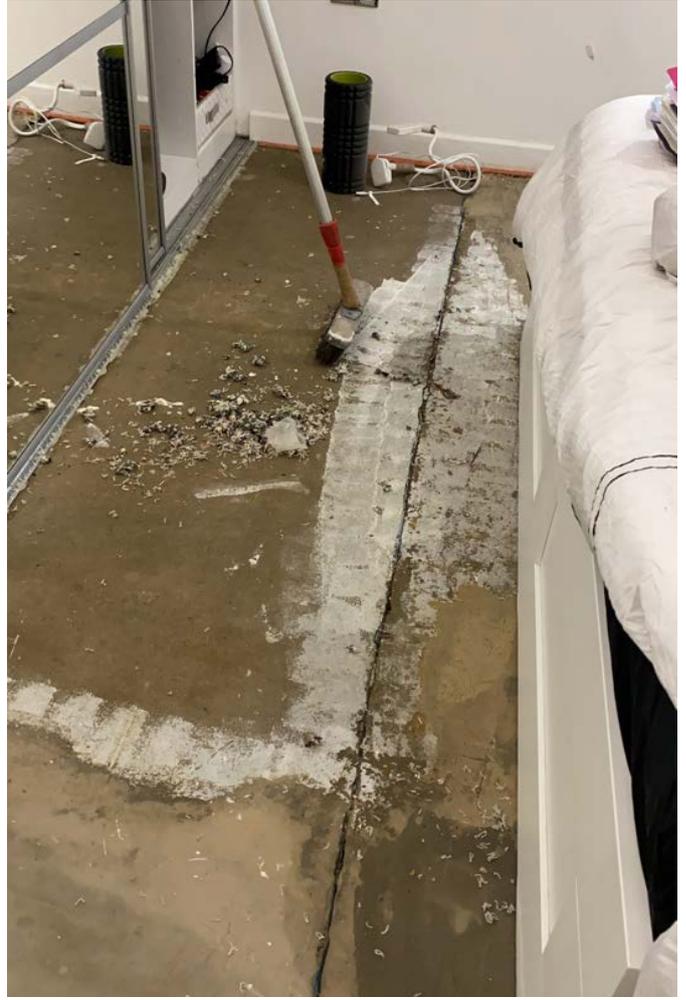
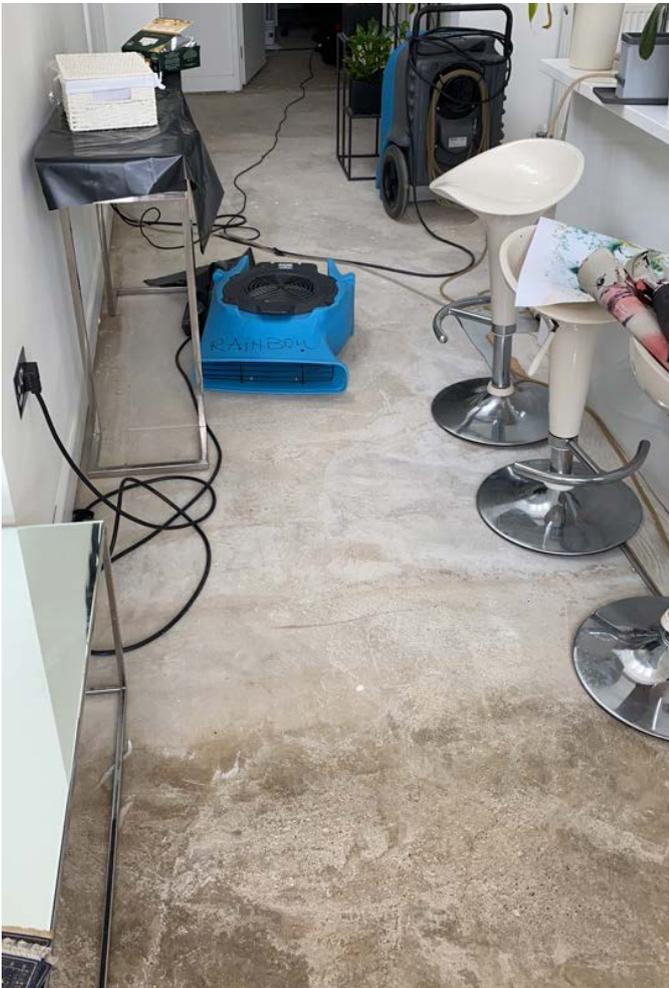
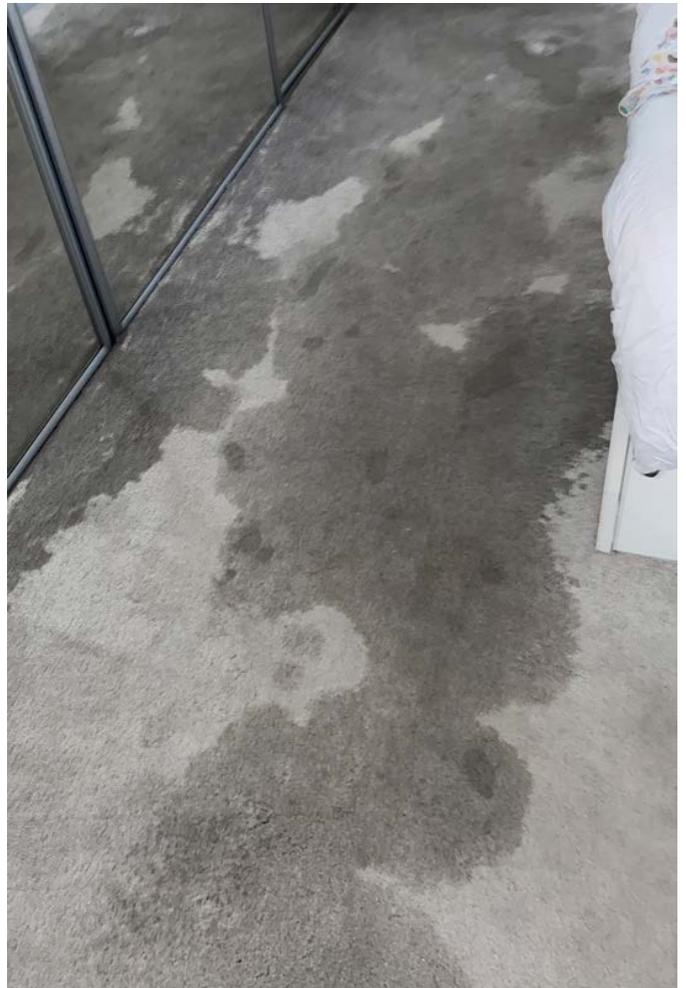
Fifield Road Culvert - "wet spot" 8

A little further south, at the culvert under Fifield Road, Residents of properties at the pinch point of water heading north from the Drift Road all trying to get through the culvert suffer in the way they always do.

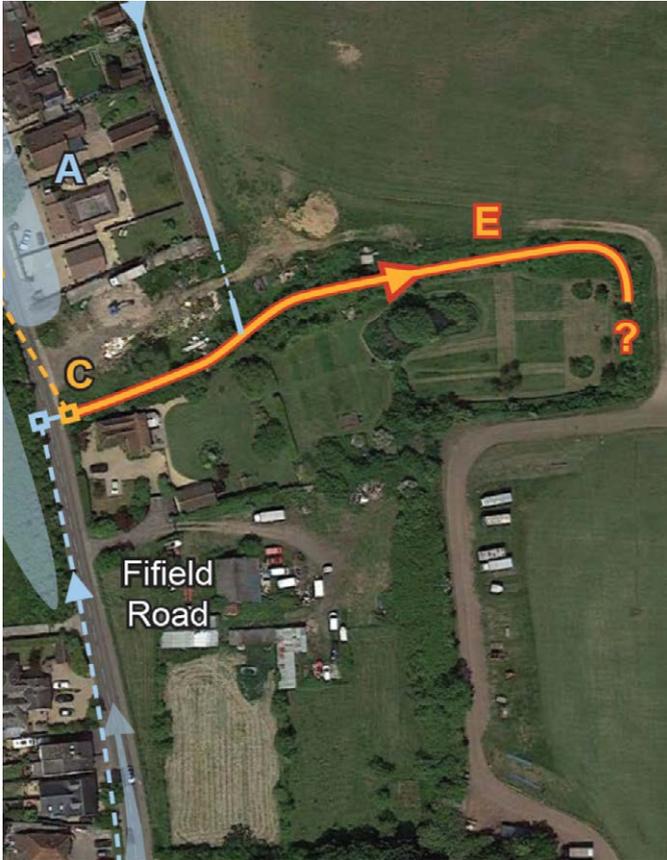
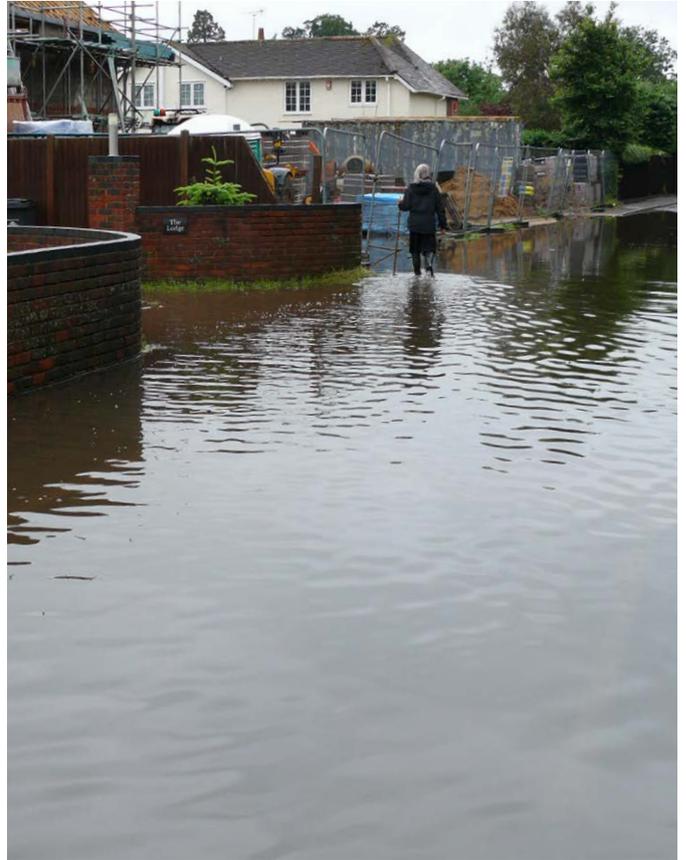
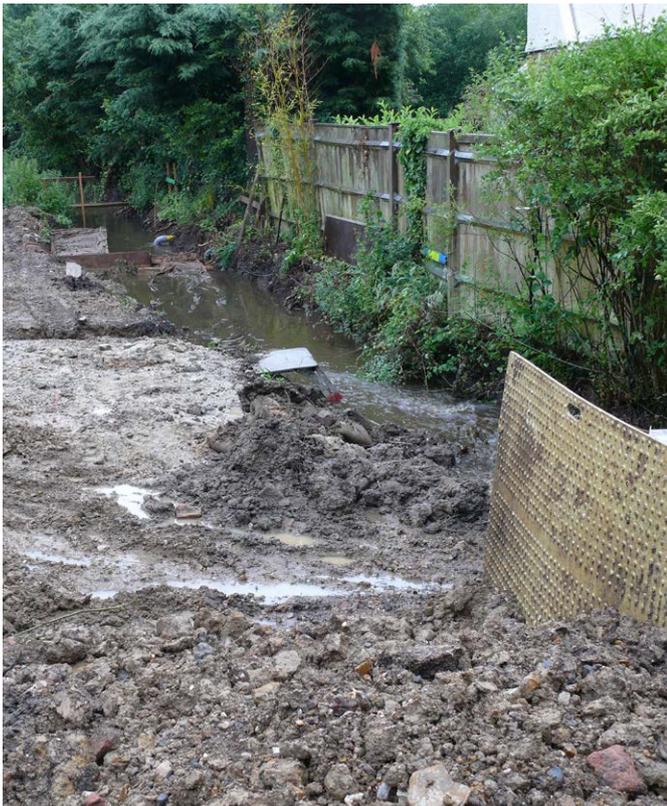
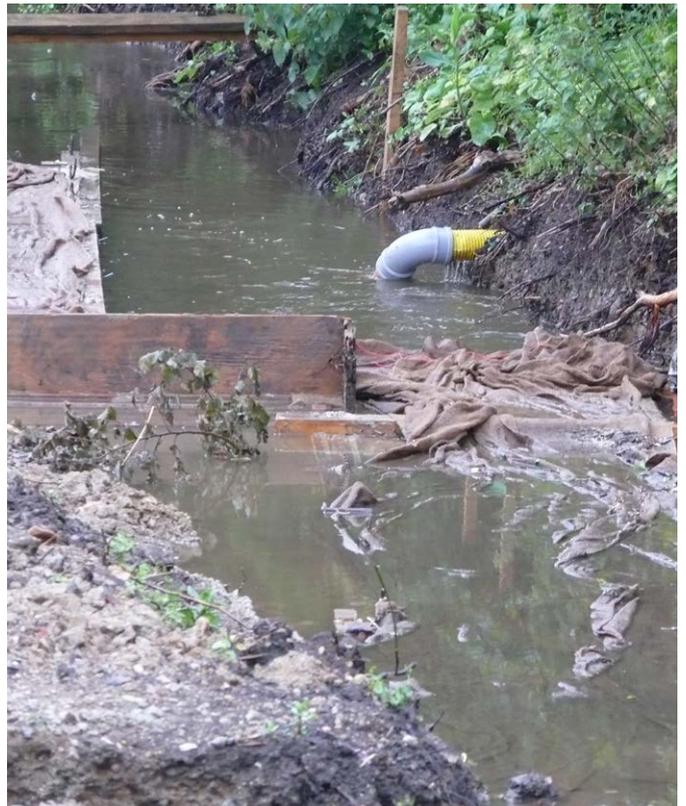
Fifield Road building site - “wet spot” 7

Just a little further south a building project is in progress which includes a crucial ditch taking water away from this area of Fifield. On this day the torrent flowing along this ditch was impressive. But it is very difficult to imagine how the amount of water in this ditch could ever be accommodated by the 600 mm concrete pipes that will be installed to do the same job.

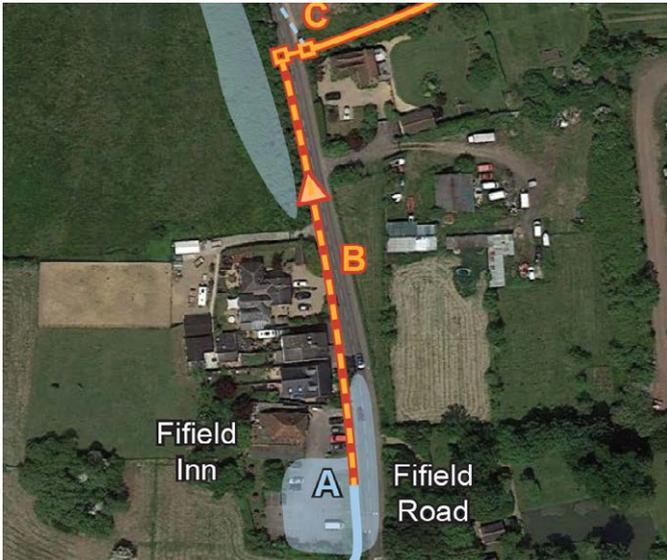
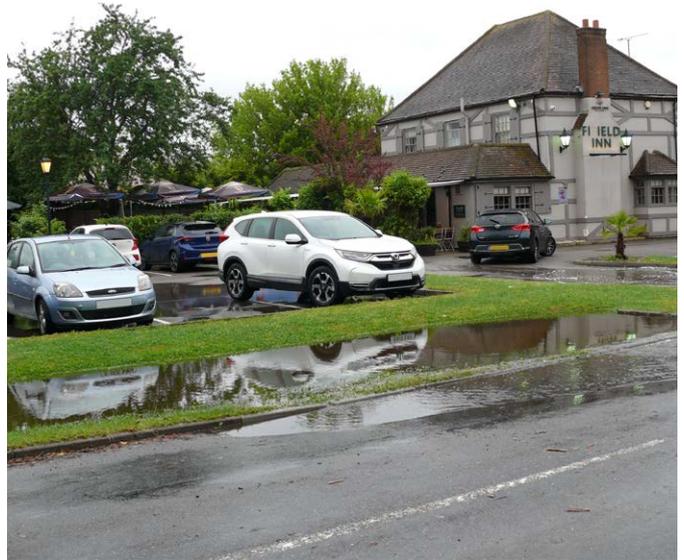
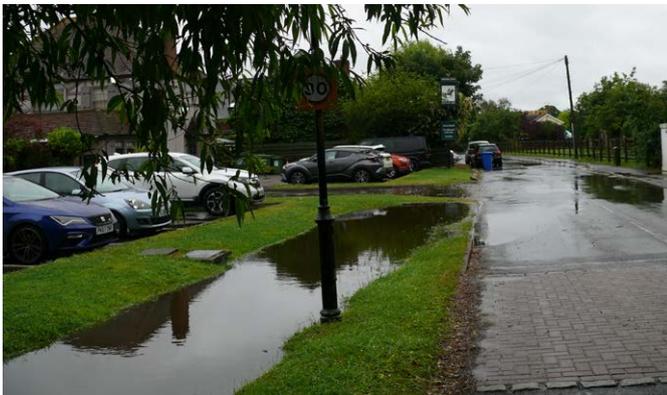
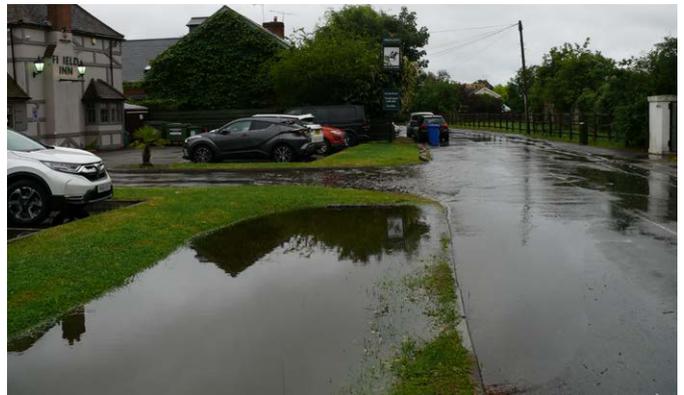
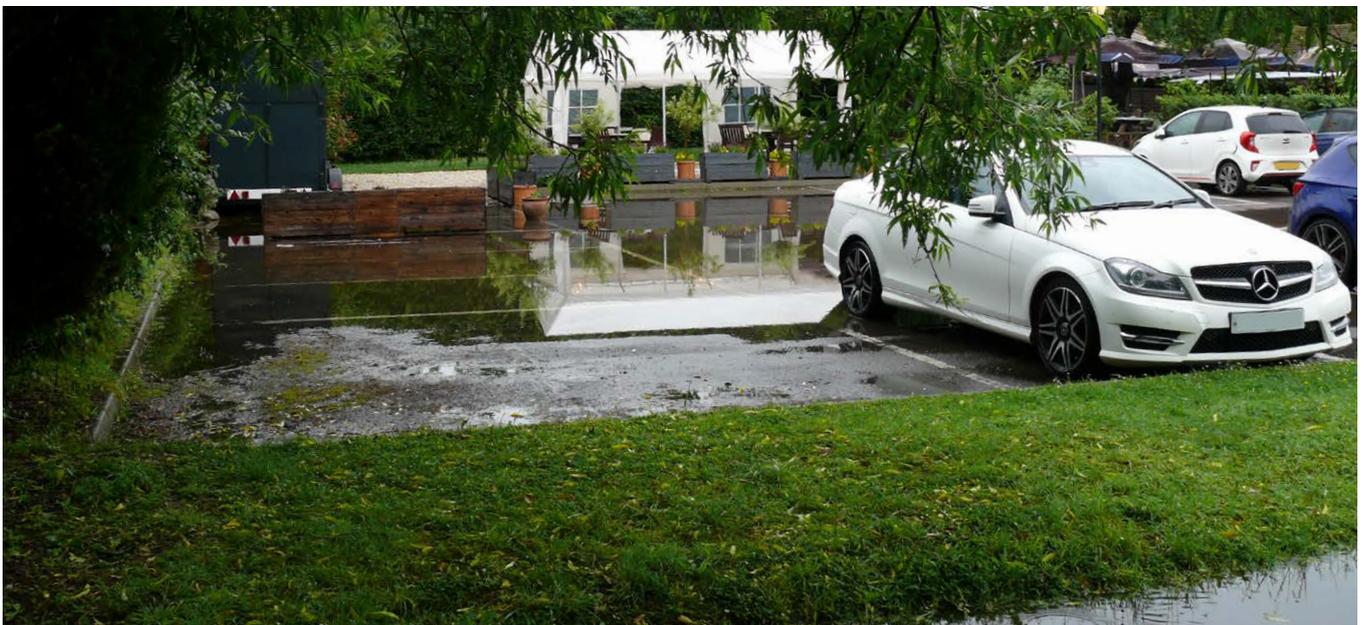
Fifield Inn - "wet spot" 7B

A few more strides further south and the ditch at the Fifield Inn is overflowing again. The pipe under the car park entrance heading north has been blocked for years and although OGAFCA has been flagging it up since 2010 absolutely nothing has been done in 11 years. So when this happens the car park fills until customers can no longer park and water flows along the road heading north. It is true that, as RBWM contractors claim, after a while some of the water finds a gully some of it can get down. But that misses the point that a local business paying substantial rates is severely handicapped.
