# Environment

## 9 Wet Spots

### Drainage report 04

21.06.2010

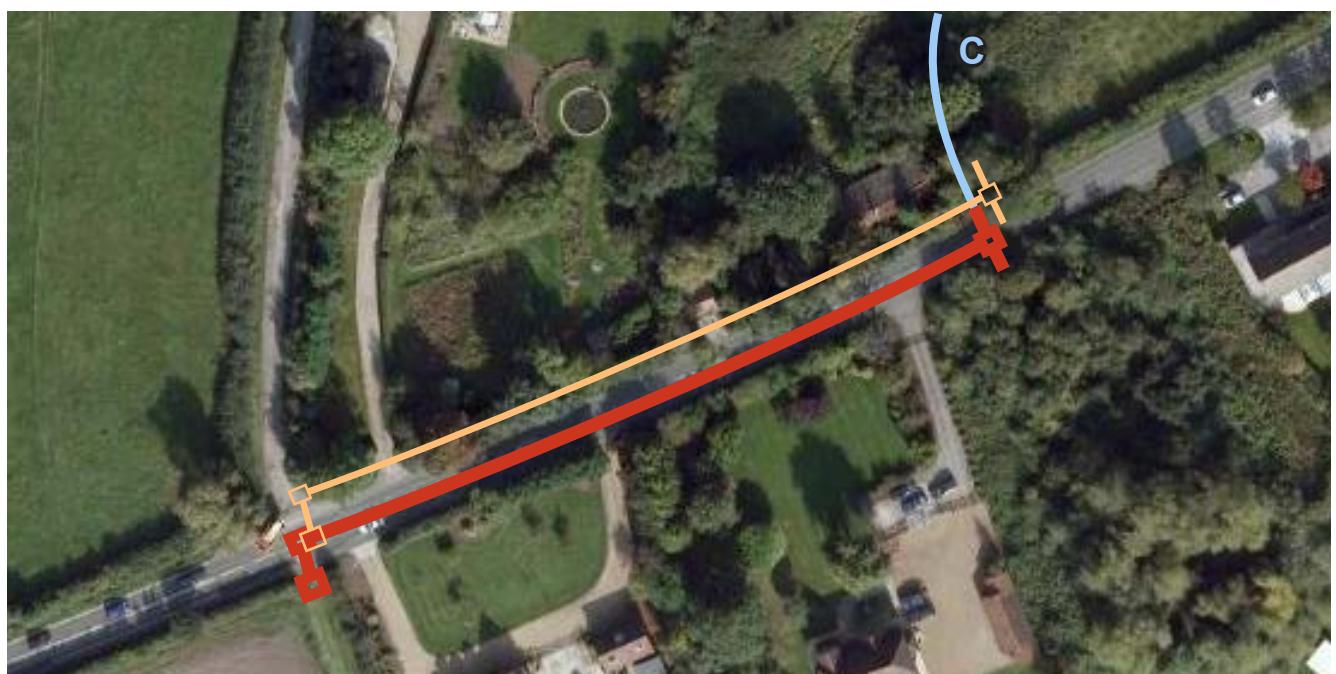
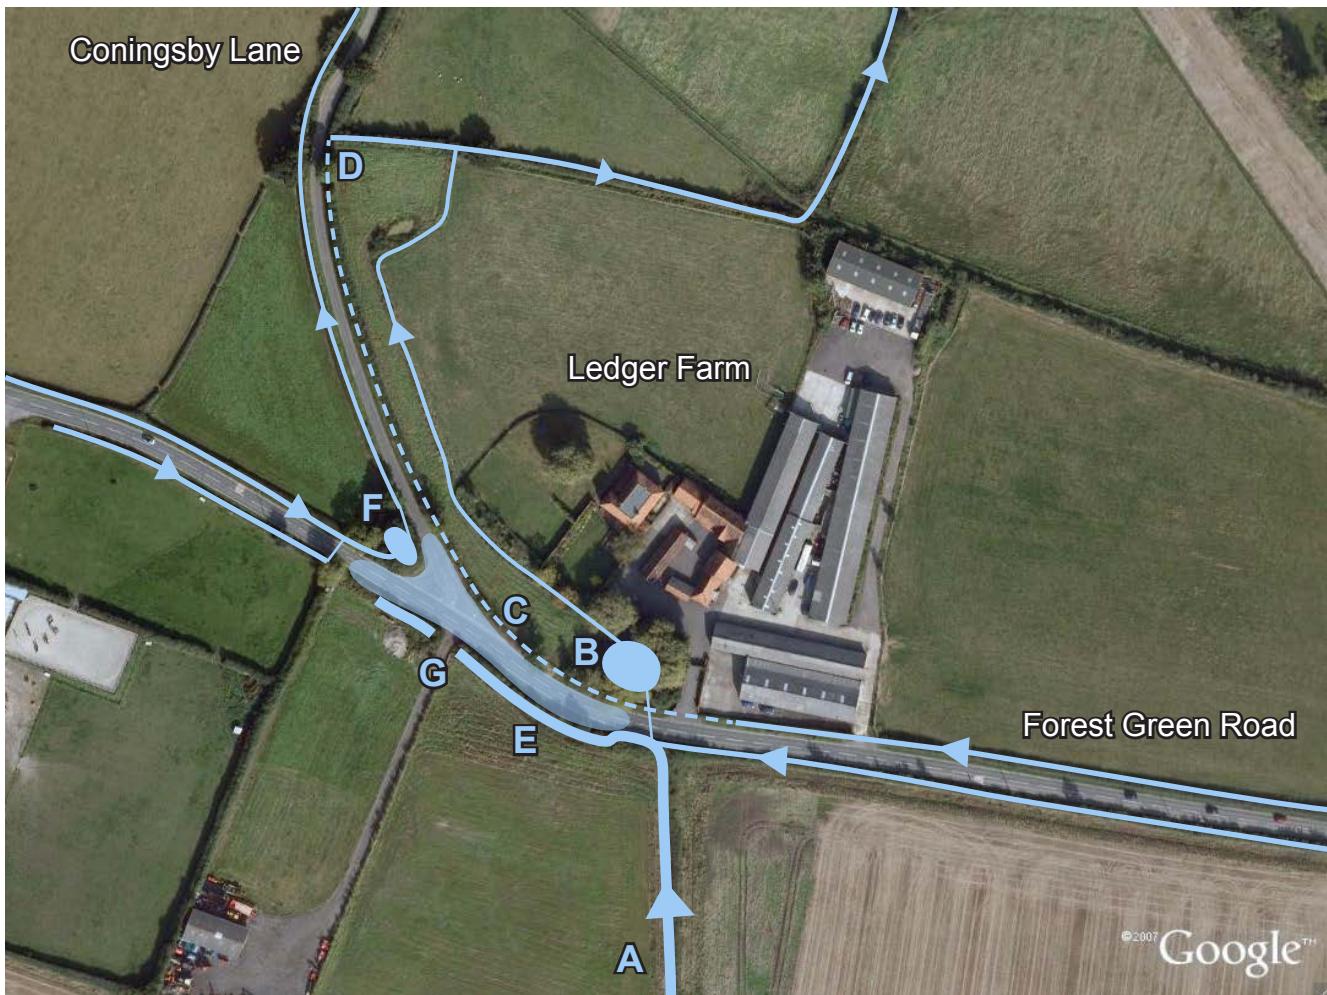
## 5 - Oakley Green House and Forest Farm area - Oakley Green Road

In times of extreme weather the problem at this location stems from large volumes of water flowing out of a field entrance (**A**).

On the south side of the road a few gullies take water into a small diameter pipe running east under the footway to exit into a small ditch at **B**, where a small, shallow culvert leads under the road into a watercourse (**C**). Water from the properties south of the road also runs into this small diameter sub footway pipe.

An insubstantial ditch starting at the drive entrance to Oakley Green House runs east along the north side of the road with small culverts under entrances and leading also to the watercourse (**C**).

These two insubstantial drainage routes simply cannot cope with the sheer volume of water flowing out of the field in times of very heavy rainfall. As a result the road becomes flooded, and as part of the grounds of Oakley Green House are lower than the road the water recently left a tide mark on the exterior wall of the house.

It is initially tempting to think that as a major watercourse route (**D**) runs north via a large double culvert under the road not far to the west that this might offer some sort of solution. Unfortunately the ground rises slightly between **A** and **D**. The landowner has tried to improve things by installing an underground pipe (**E**) which falls to the route of **D**. This has turned out to be almost counterproductive. Although the watercourse at **D** is of considerable depth it becomes full and at these times water backs up the pipe. If this pipe is still operational consideration may need to be given to blocking it as it is exactly at those times that more water arriving at **A** needs to be avoided !

- 1 - Doubling the diameter (at least) of the sub footway pipe on the south side of the road and increasing the depth of the ditch where this exits (**B**).
- 2 - Increasing the number of gullies that feed into this pipe, particularly at the western end near the field entrance - possibly even considering starting the pipe from an entrance grid and sump at the entrance.
- 3 - Replacing the road culvert crossing north under the road at **B** to feed into watercourse **C** with one of much larger diameter.
- 4 - Increasing the width and depth of the ditch running along the north side of the road, ensuring that all pipes under entrances are of substantial diameter, and ongoing maintenance of this route to the watercourse (**C**).

would entail the installation of a major storm drain under this section of Oakley Green Road starting at a grid and sump arrangement at entrance **A** and leading out into watercourse **C**.

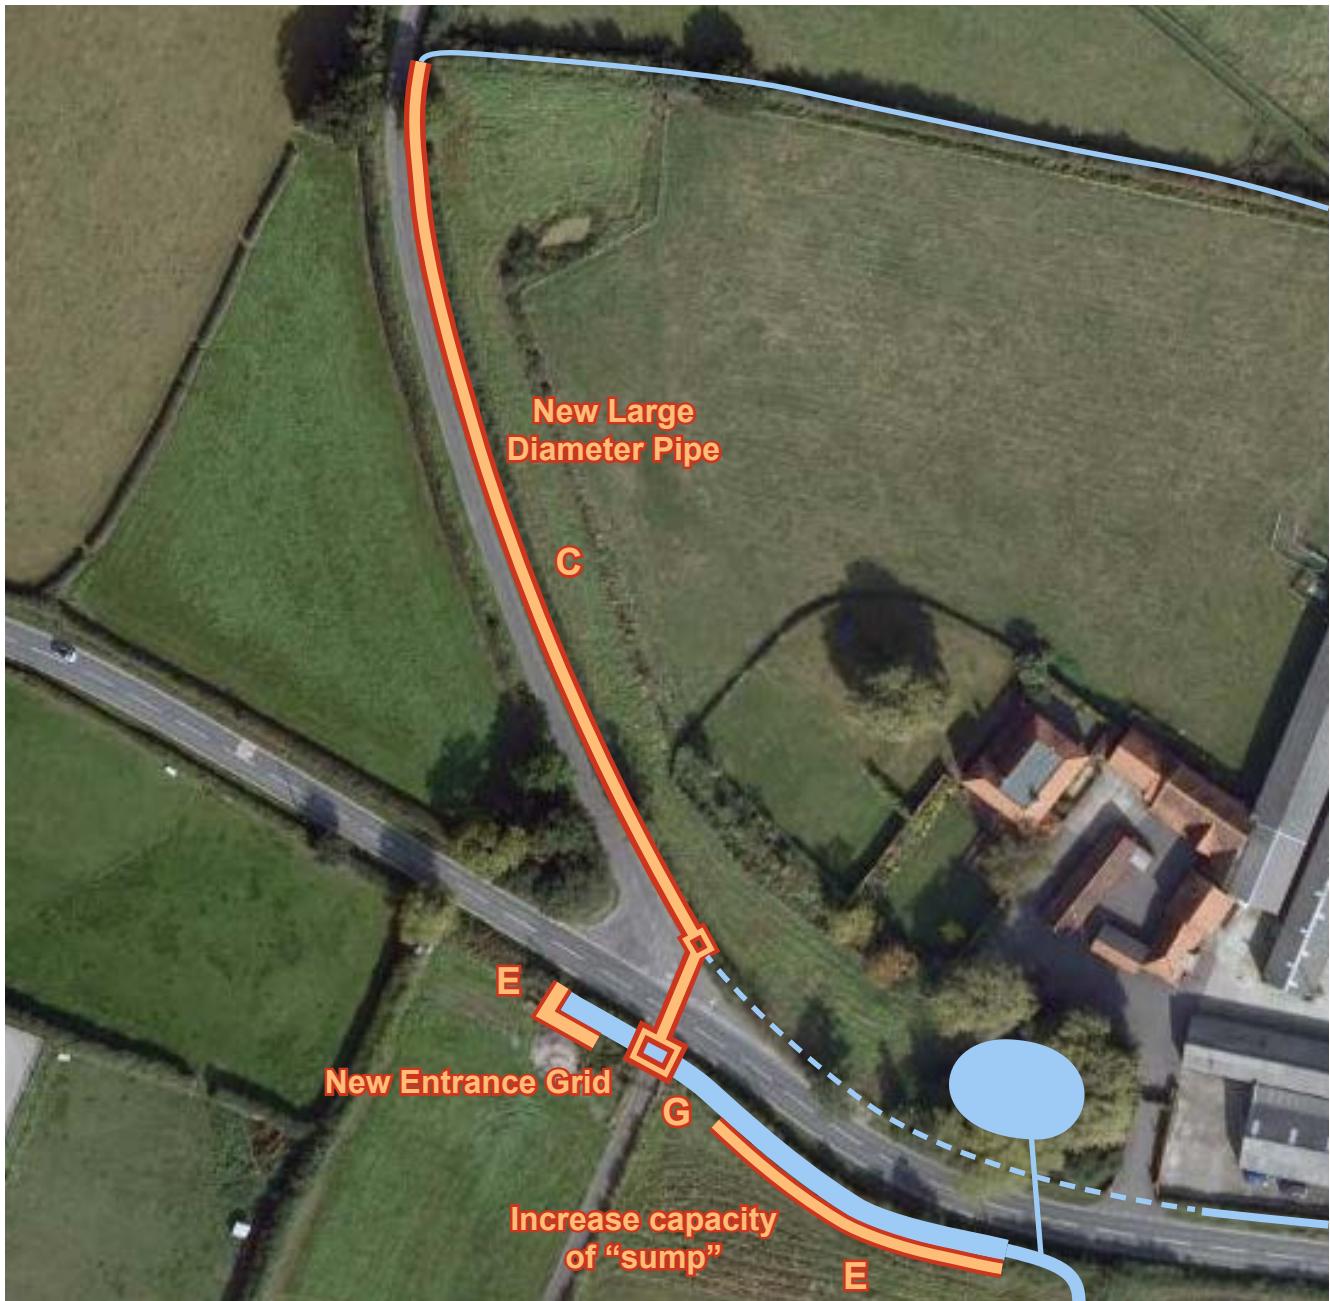
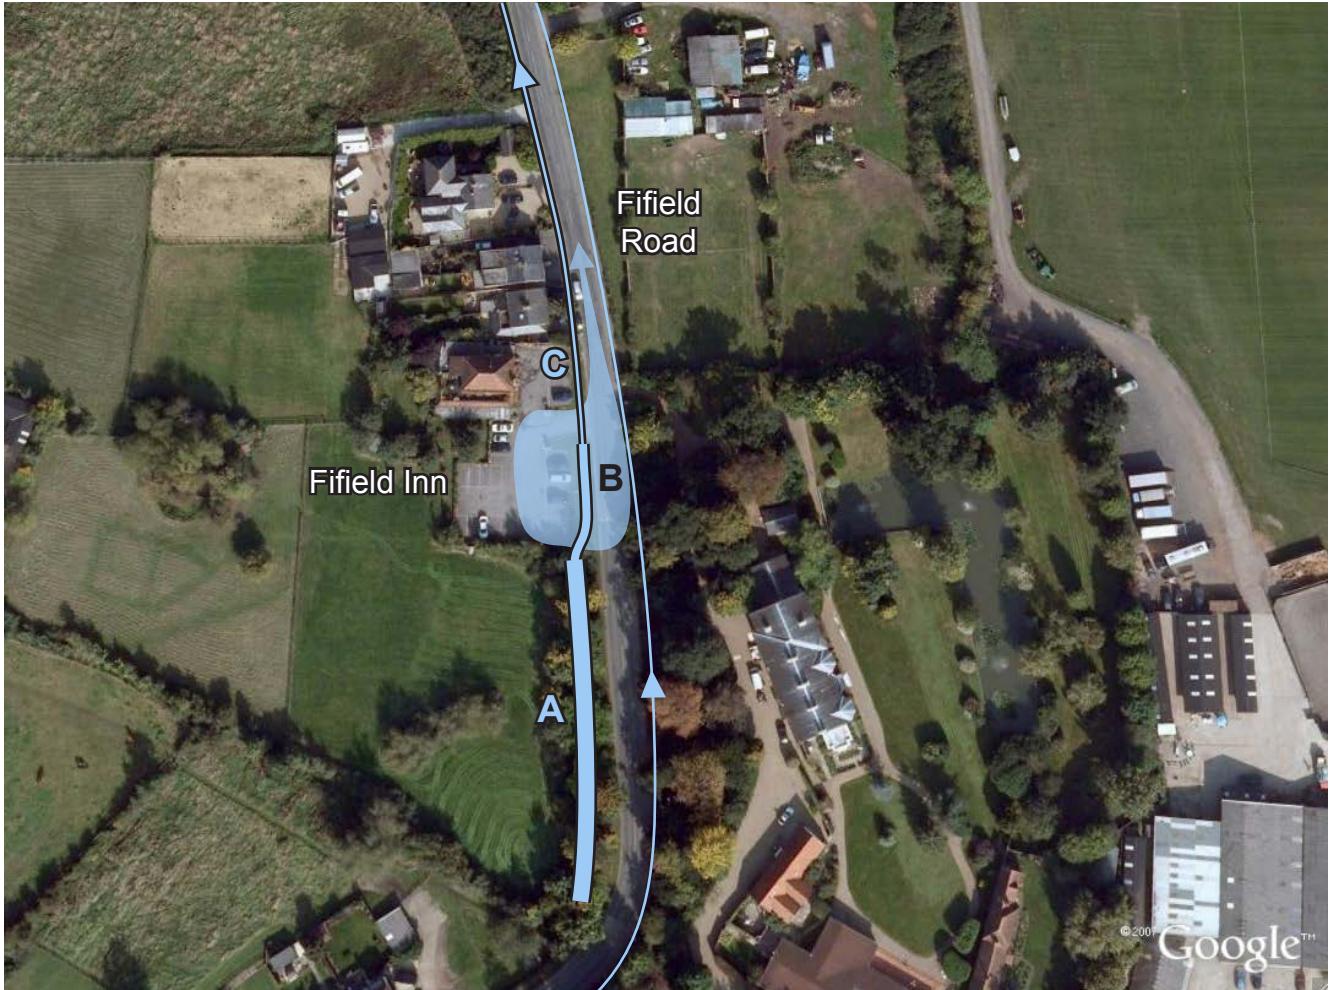
## 6 - Ledger Farm - Coningsby Lane (south) and Forest Green Road

Water flows down from the Drift Road higher ground heading north (A). The original route took it directly under the road through a 30cm pipe into the pond (B) at Ledger Farm and then on northward to join the ditch at the northern boundary. In times of extreme weather Ledger Farm suffered frequent flooding of the pond and have now installed a valve on the northern side of Forest Green Road to allow them to shut off the flow into the pond.

The only remaining outlet now becomes the 30cm underground pipe (C) running north under the eastern verge of Coningsby Lane which exits at a manhole (D) and flows east along the boundary ditch and then north under the footpath to arrive eventually at the culvert under Fifield Road at the old chapel.

At these times the capacity of the pipe system is simply too restricted and water collects in a large ditch (E) inside the hedge line to the south of the road. This contains a large quantity of water throughout the year, even during the summer months.

From the west the ditch to the south of the road is culverted to join the northern ditch and then into a depression on the corner of Coningsby Lane which becomes a pond in winter (F). Water from here flows north along the ditch on the west side of Coningsby Lane.

In times of extreme weather the water in the “sump” ditch (E) south of the road overflows and flows out through the entrance (G) to flood the road junction. More water also flows off the track and through the entrance onto the road. Gullies in the road at the junction take this water into the pipe (C).

1 - Increase the capacity of the “sump” (**E**).

2 - Install a grid crossing at entrance (**G**).

3 - From beneath the grid at the entrance take a LARGE diameter culvert (or a pair) to the eastern corner of Coningsby Lane to a manhole chamber.

4 - Replace Pipe (**C**) with one of at least 60cm or more.

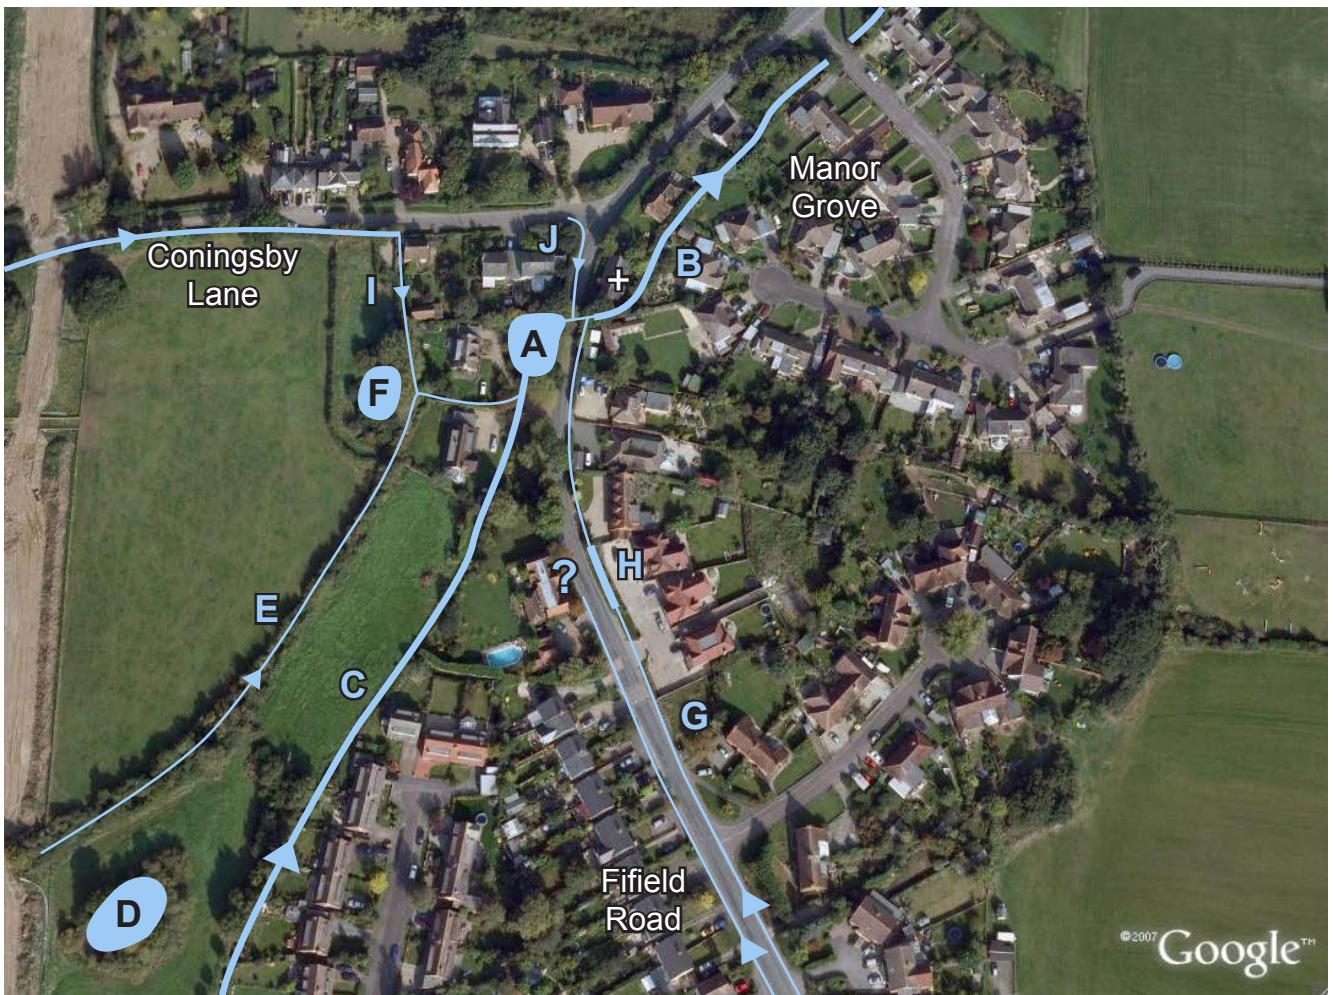
## 7 - The Fifield Inn - Fifield Road (south)

Water coming off the field to the west of Fifield Road collects at **A**. This contains water all year round and at times of high rainfall overflows into the ditch (**B**) between the pub car park and the road. From this a pipe runs north under the entrance to the car park and along the Fifield Road (**C**).

Inevitably the volume of water eventually exceeds the capacity of the pipe and the ditch overflows into the car park and onto the road where it gushes its way north trying to get down the gullies into the pipes on both sides of the road.

All this water above and below the road heads north to join all the rest at the culvert at the old chapel.

- 1 - Increase the capacity to hold water at **A**. By excavating and extending this as much as possible the overflow might at least be delayed. This will need discussions with the landowner and it might be possible to improve this further by the excavation of a pond at the south east corner of the field.
- 2 - Increase the capacity of the route north (**C**). This is obviously costly and disruptive and the ultimate solution to this and all the problems along the Fifield Road is a large diameter storm drain that starts here and runs all the way north to exit in the roadside ditch north of Longlea Nursing Home.

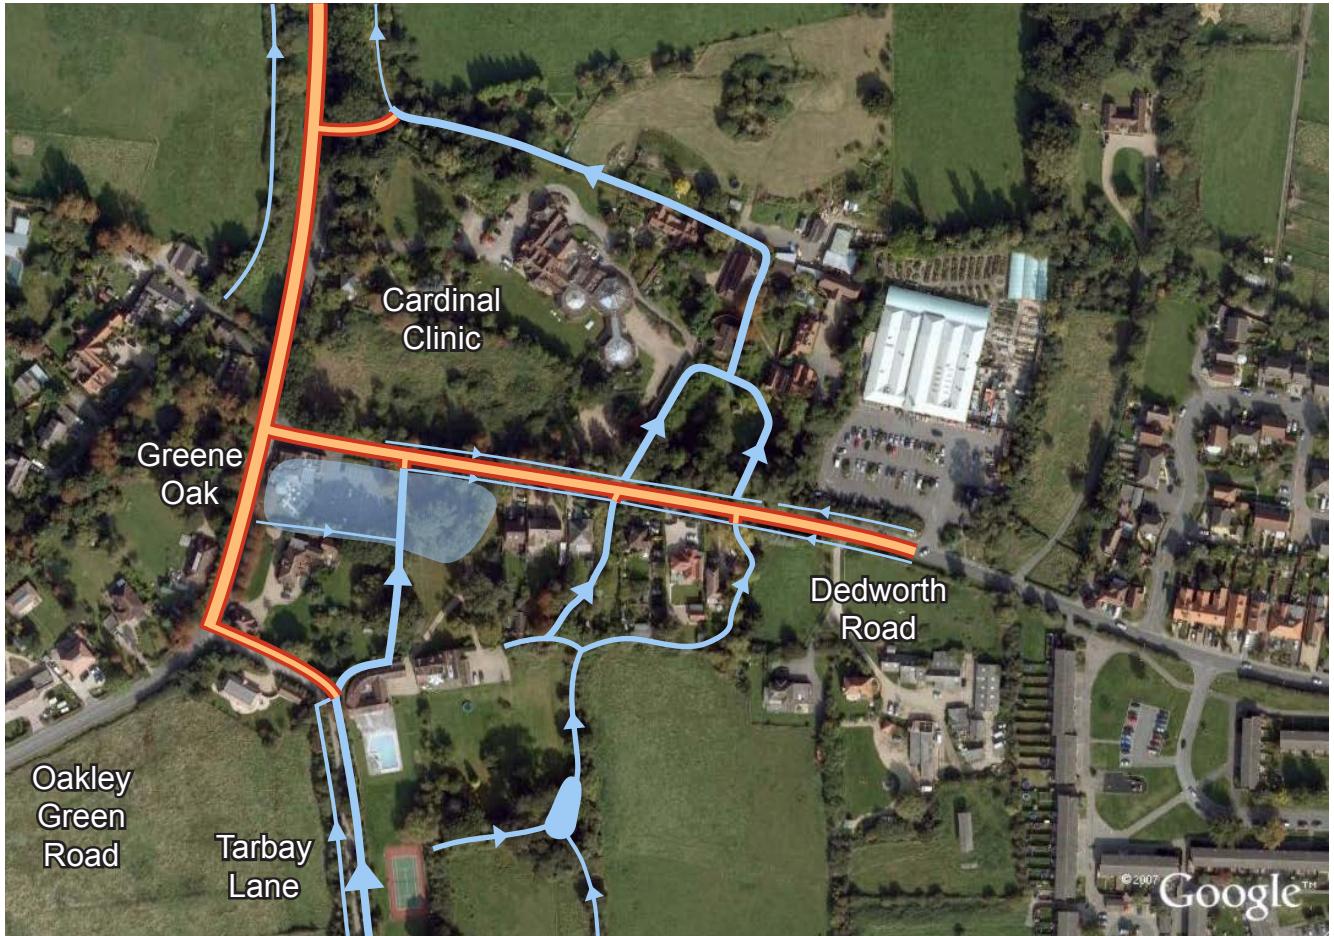
## 9 - Cardinal & Hand Clinics - Oakley Green Road & Dedworth Road

**(A)** A ditch runs down the slope of Tarbay Lane on the western side and a very substantial one on the eastern side. In extreme weather the quantity of water coming down this route must be considerable. When the ground levels as the lane turns west to join Oakley Green Road the ditch becomes far less significant and stops at the road. There is a culvert under the lane taking water to join the eastern flow (**B**) which follows a substantial route north to the Dedworth Road.

Smaller ditches feed a pond (**C**) which exits along a ditch northwards to join others (**D**) taking more water to the Dedworth Road. Significant volumes of water therefore find their way to a low point on the Dedworth Road. The road rises slightly in both directions so the roadside ditches are also feeding water to this point (**E**).

Culverts under the road take all this water into two routes in the grounds of the Cardinal and Hand Clinics. These join to continue north then west (**F**) to finally exit the property and head north towards the A308 (**G**). This route is substantial and well maintained but despite this the grounds suffer frequent and extensive flooding. Although the onward route north (**G**) is not so substantial it is not clear that improving this would relieve the problem entirely. The sheer volume of water trying to pass through the site would still overcome the system.

This whole area becomes generally saturated to the extent that the Greene Oak (**H**) experience water rising in their cellar regularly, the ground floor is threatened by surface water in the car park, and the grounds of The Malt House next door are also covered in water near the Dedworth Road.

Once again a comprehensive solution would involve a very costly large capacity storm drain running west along Dedworth Road to join another running north towards and under the A308.
