## **9 Wet Spots 2015** **Where are we after 6 years ?**

### **Drainage report 05**

19.09.2015

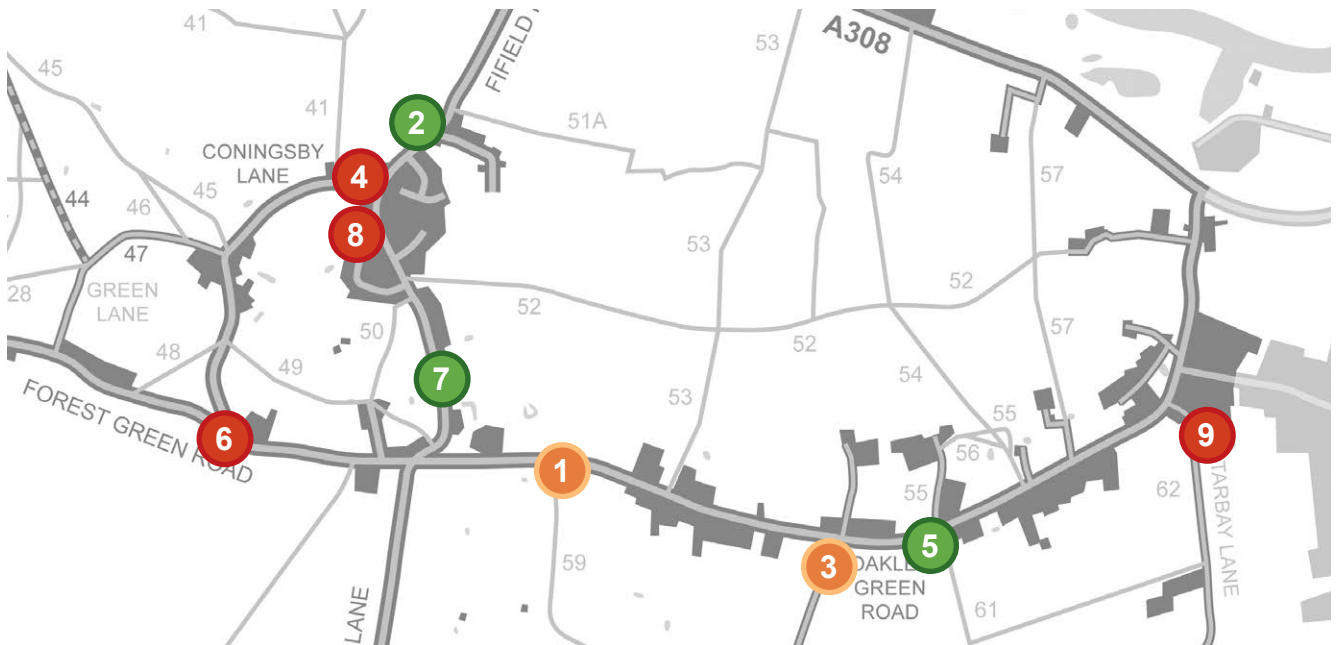
## 9 “Wet Spots” - the state of play in September 2015

- 1 Cricket Ground - Oakley Green Road** - page 3  
 Some improvement but no satisfactory solution until capacity of culvert and chamber at SW corner of site and pipes northward along boundaries increased and-or sump holding capacity south of road increased.

- 2 Area of speed hump and Fifeild Road (north)** - page 4  
 Ditch re-instated but needs regular pressure for annual clearing. Sub-footway pipes and culverts north of Wayside Stables repaired. East-west flowing culvert north of Longlea Home blocked as trial.

- 3 Braywood Lodge - Oakley Green Road** - page 5  
 Volunteers cleared ditches and Streetcare jetted roadside pipes. Resident reports problem recurs. After observing next event may need to recommend land drainage pipe installation.

- 4 Coningsby Lane shambles** - page 6  
 Some minor temporary work to clear ditch and improve roadside parking courtesy of local farmer. Streetcare avoiding proposed action due to resident's objection. Requires Streetcare commitment.

- 5 Oakley Green House and Forest Farm area - Oakley Green Road** - page 7  
 Streetcare partially carried out OGAFCA recommendations. 2 new gullies installed in gate opening feeding into sub-footway pipe. Residents report there has been no recurrence of this flooding problem.

- 6 Ledger Farm - Coningsby Lane (south) and Forest Green Road** - page 8  
 No progress. Sadly any improvement in capacity and flow at this site would result in increased problems at “Wet Spot” 8. Best short term hope for improvement probably working with landowner (Phil Mortimer ?) to substantially increase sump holding capacity south of Forest Green Road.

- 7 Fifeild Inn and Fifeild Road (south)** - page 9  
 New roadside pipe and gullies installed and culverts jetted to re-instate route via chamber under pavement at corner of Garden Cottage eastwards past polo pitch. Landowner promised to clear ditch in autumn-winter 2014 but this has still not been done. This may cause problems and needs monitoring.
