# the problem of flooding in **CONINGSBY LANE**

compiled by  
Rod Lord, Old Lodge Farm, Coningsby Lane, Fifield  
01628 627032 [rod@rodlord.com](mailto:rod@rodlord.com)

## **The problem of flooding in CONINGSBY LANE**

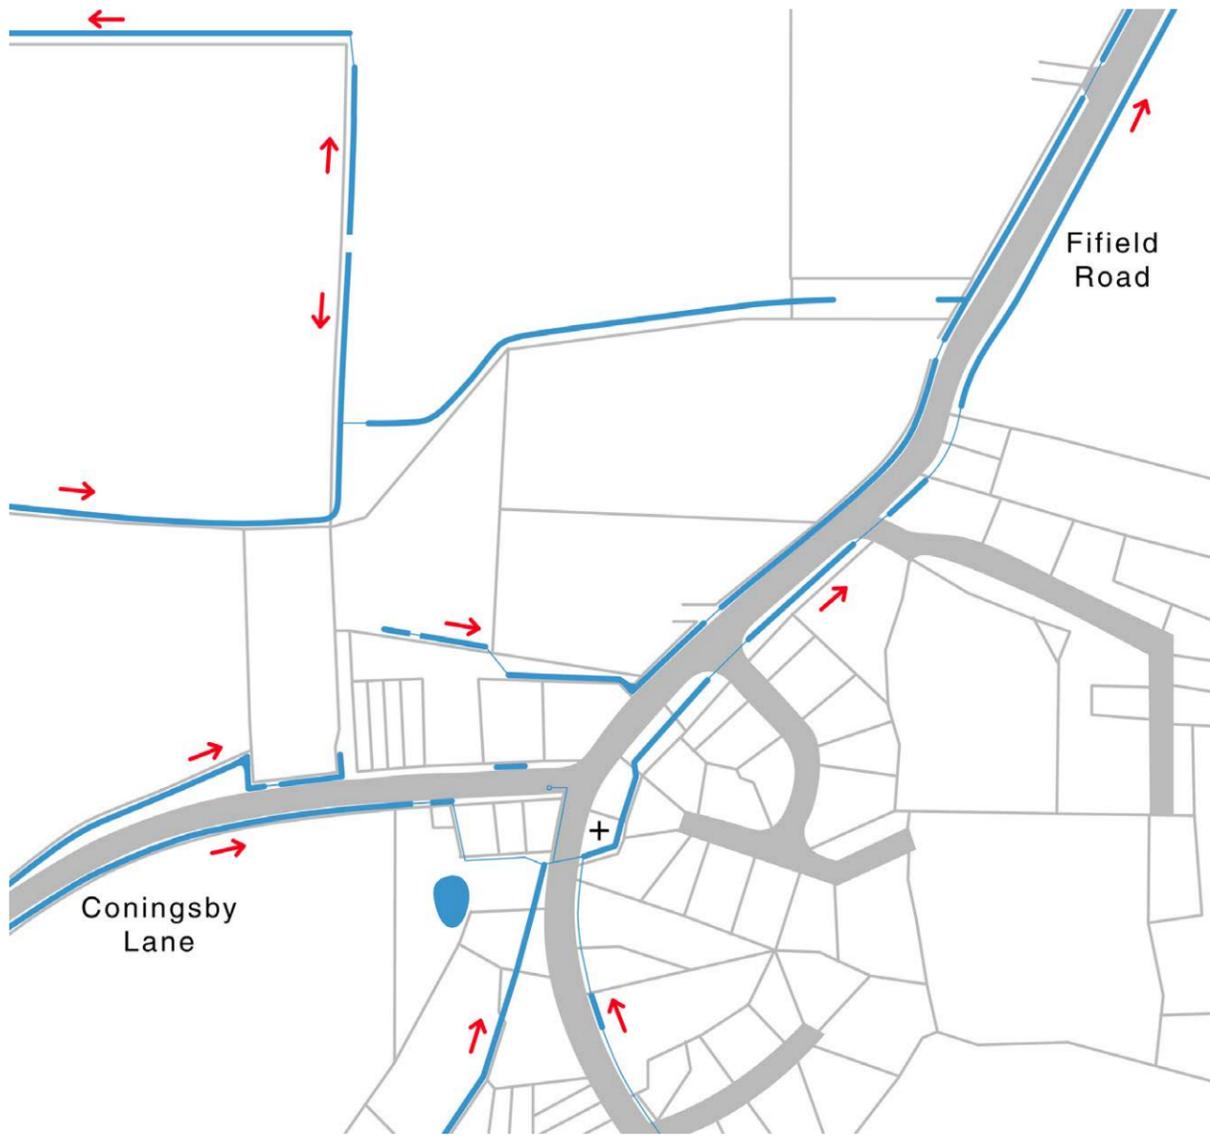
## The existing situation

Ditches on both sides of the lane carry water eastward towards the Fifiel Road.

On the north side water can only accumulate along the hedge of “The Mulberries” as there is no route for it from there. Apparently a ditch running north inside the “Mulberries” boundary line was piped some time ago, but this is obviously no longer functioning. There was obviously once a ditch running down the eastern side of the “Mulberries” beside the footpath access to the fields behind, but this was overgrown and hard to find as long ago as 1984. The only route currently available is out onto the road where it forms a large shallow lake. Eventually some of it finds its way into the ditch on the south side and some runs down the road to contribute to a lake that forms at the road junction.

The ditch on the south side, now joined by water from the north side via the road, arrives at a 6-inch diameter pipe which takes it south round “Parkside” to join large quantities of water flowing north. This all now has to pass through a culvert under the Fifiel Road. At this point it is joined by yet more flow heading north. This is arriving via pipe running up the eastern side of the Fifiel Road through the village. It exits briefly into a ditch in front of the “Hare and Hounds” garden before again trying to get through a pipe to join the main flow of water round the back of the Chapel, and thence by a convoluted route eventually to a large ditch flowing north towards the A308 along the eastern side of the Fifiel road.

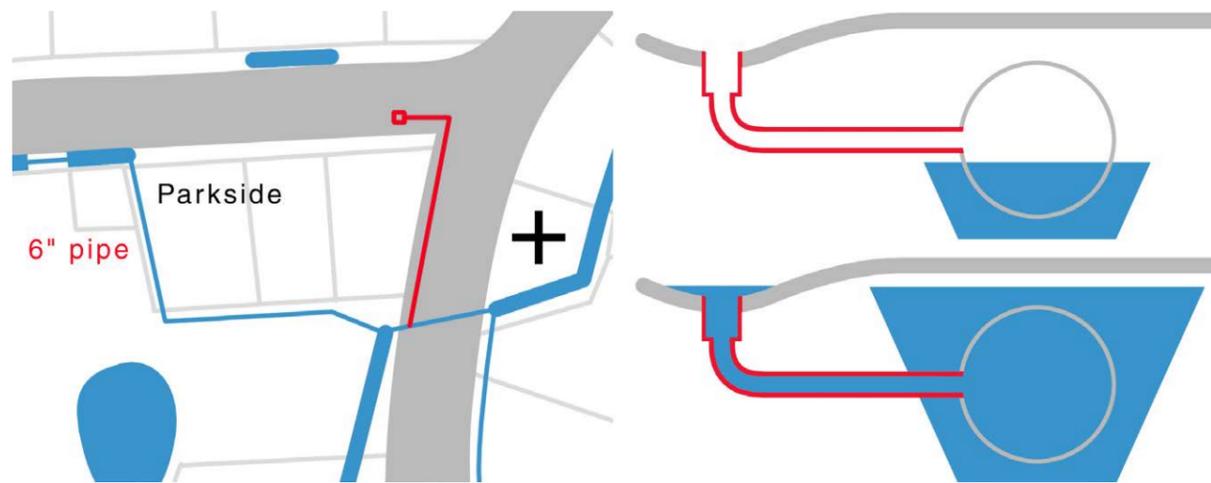
The first of these is of course into the lake already at the junction of Coningsby Lane. Once this is equalised it looks for roadside ditches...or houses...or the sewage system. The sewers back up and the ground water level rises beyond what is at the best of times only 20” or so below the surface. The first ditch capable of taking this flow is north of the Nursing Home, but there is more water flowing onto the road near here off the field and through the gate just south of the Biffa site.
